Lloyd Shoals Hydroelectric Project (FERC No. 2336-094)
Relicensing Study Reports

STUDY REPORT

GEOLOGY AND SOILS

LLOYD SHOALS HYDROELECTRIC PROJECT
(FERC No. 2336)

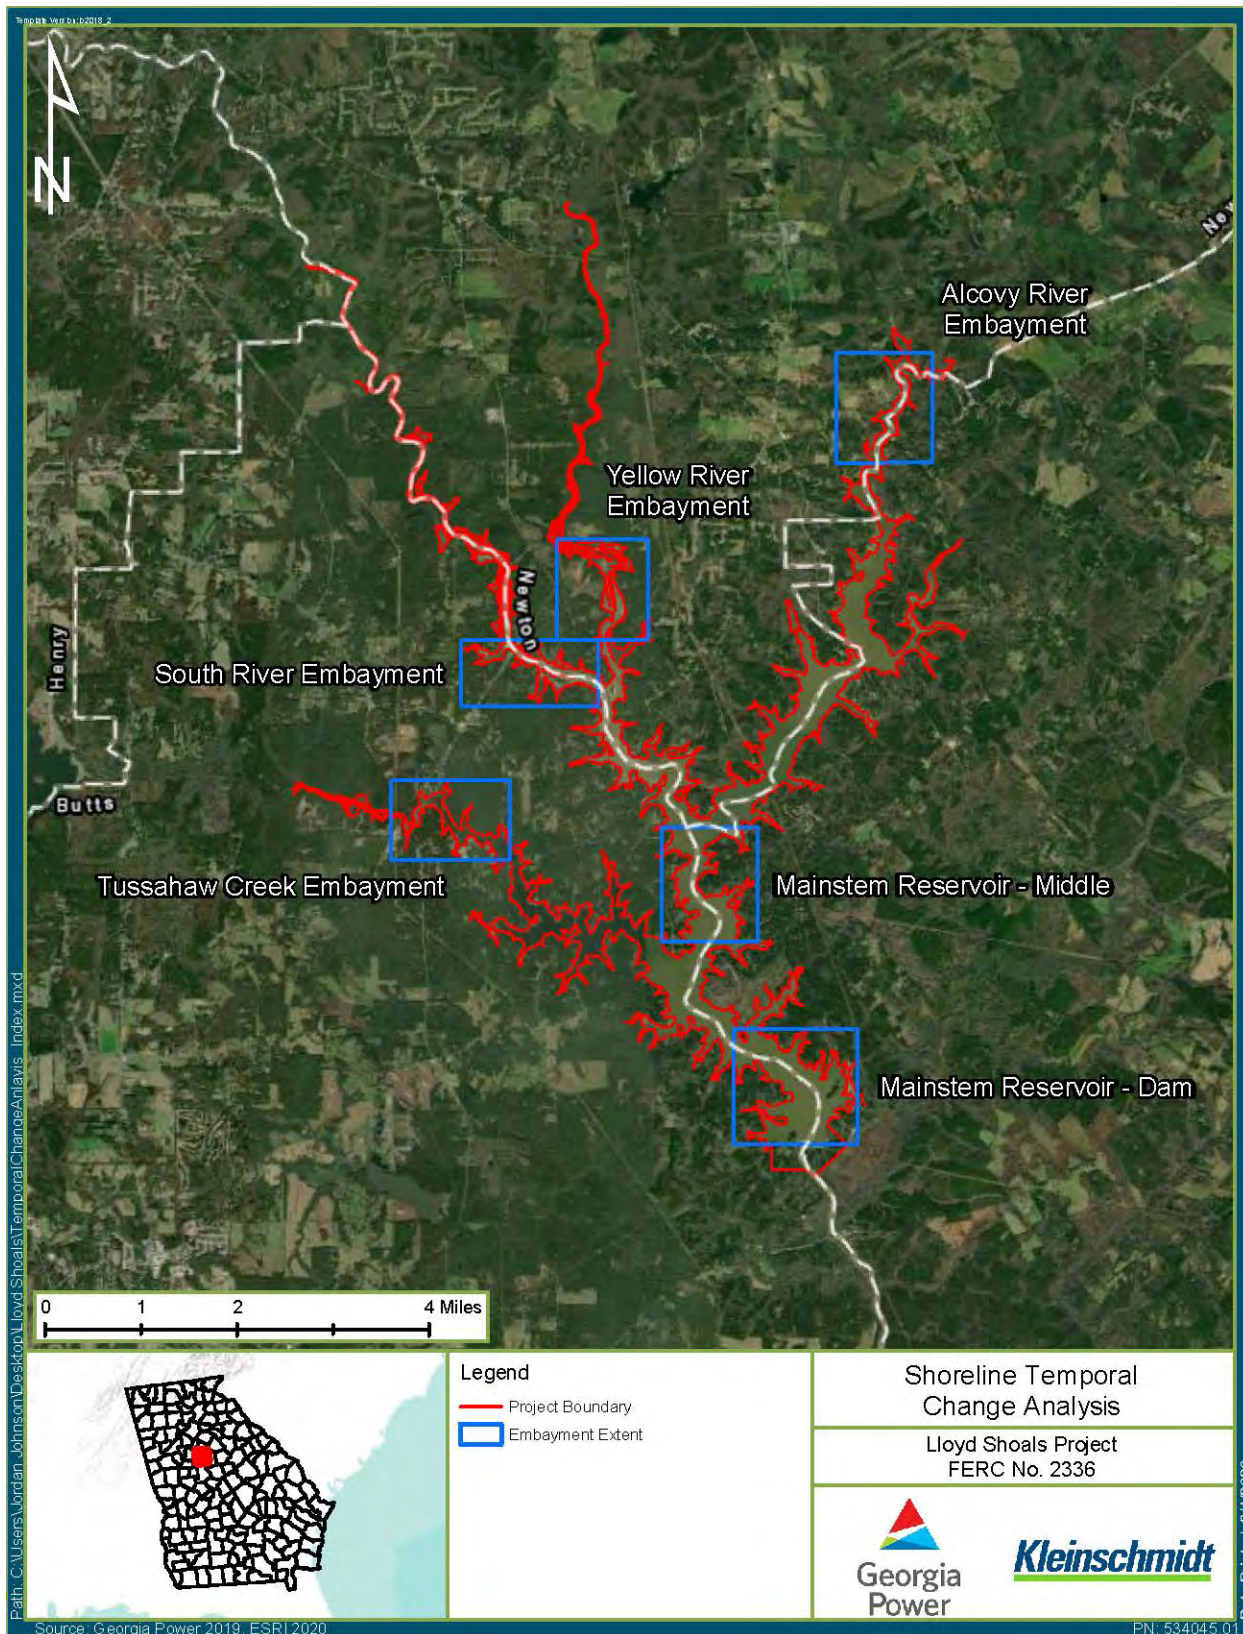
FIGURE 12 SHORELINE TEMPORAL CHANGE ANALYSIS INDEX

Figure 12 provides an index map of the six areas of Lake Jackson evaluated for temporal change in shoreline conditions. The predominant land uses in the project area are low-density residential along the shorelines, deciduous forest, evergreen forest, open space, and forested wetlands. Clusters of low-intensity urban uses are generally found along the northwestern edge of the Project, along the South and Yellow Rivers in Henry and Newton counties. Lands used for row crops or pasture are also found throughout the project area. Based on the aerial photography comparisons described below, there has been little overall change in the predominant land uses surrounding the Project since 1993.

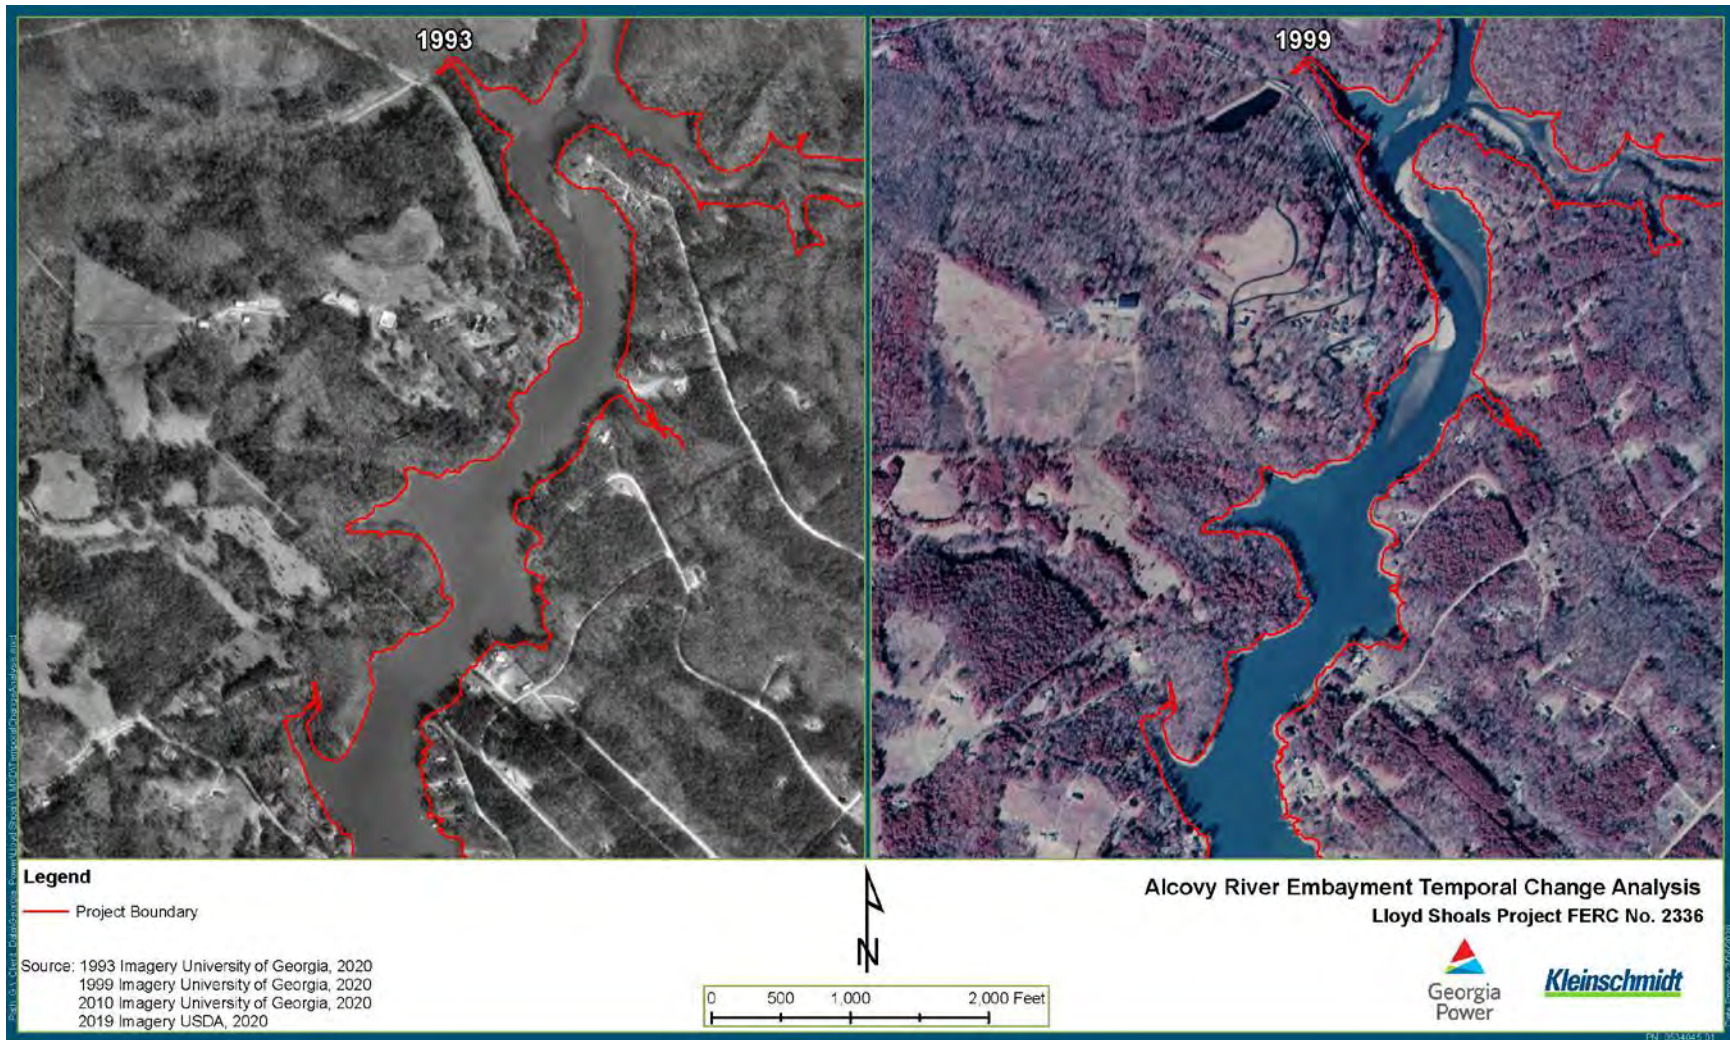
FIGURE 23 SHORELINE TEMPORAL CHANGE ANALYSIS ALCOVY RIVER

Figure 23 and Figure 24 compare the 1993, 1999, 2010, and 2019 aerial imagery of the Alcovy River embayment. This section is in the upstream reach of the embayment. Similar to the South and Yellow River embayments, this section shows signs of sediment deposition as conditions change from a riverine to a lacustrine system. Sediment deposition is primarily focused in the upper portions of the reach near bends in the river channel. Deposition has resulted in the creation of sandbars and islands that appear to grow and shrink as natural sediment transport processes occur over time. The area has experienced increased residential construction over the time period, although not of the same magnitude as the Tussahaw Creek embayment. Homes along the shoreline were primarily built along the eastern shoreline. Uplands areas of the eastern side have remained primarily undisturbed aside from residential construction. The western side has agricultural fields in the upland boundaries. Only one survey section occurred in this area, AR-27. It was classified as natural with stable banks and had no shoreline stabilization practices.
