2021 Annual Groundwater Monitoring and Corrective Action Report

Georgia Power Company – Plant Mitchell

Ash Ponds A, 1, and 2

Putney, Georgia

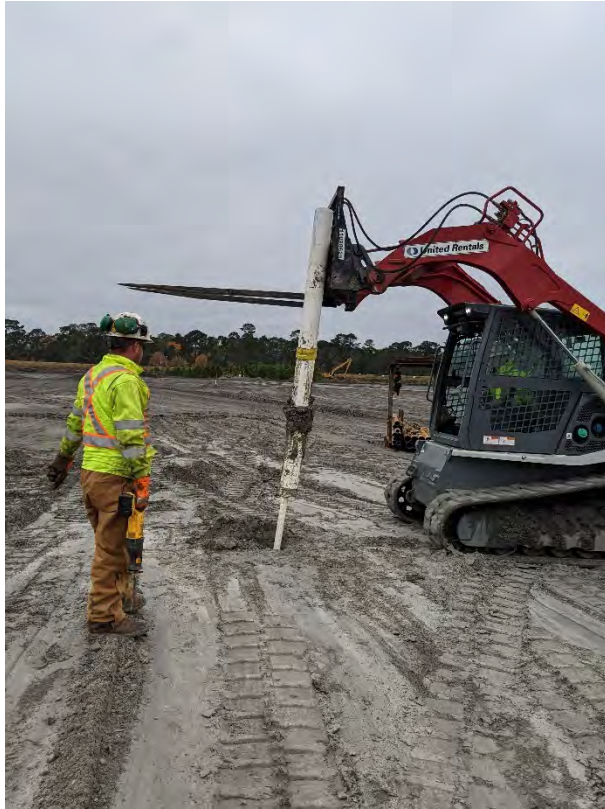
Wood Photographic Log	PZ-03R
Site: Plant Mitchell, Albany Georgia	1
Photographer: Daniel Howard	Date: 12/17/20

Removal of riser pipe and outer casing above ground surface, 6 ft 9 inches.

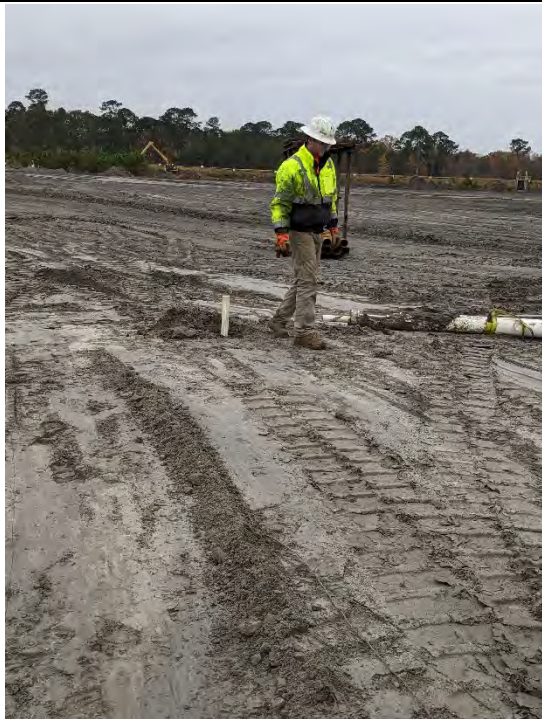
Wood Photographic Log	PZ-03R
Site: Plant Mitchell, Albany, Georgia	2
Photographer: Daniel Howard	Date: 12/17/20

Casing above ground surface has been removed.

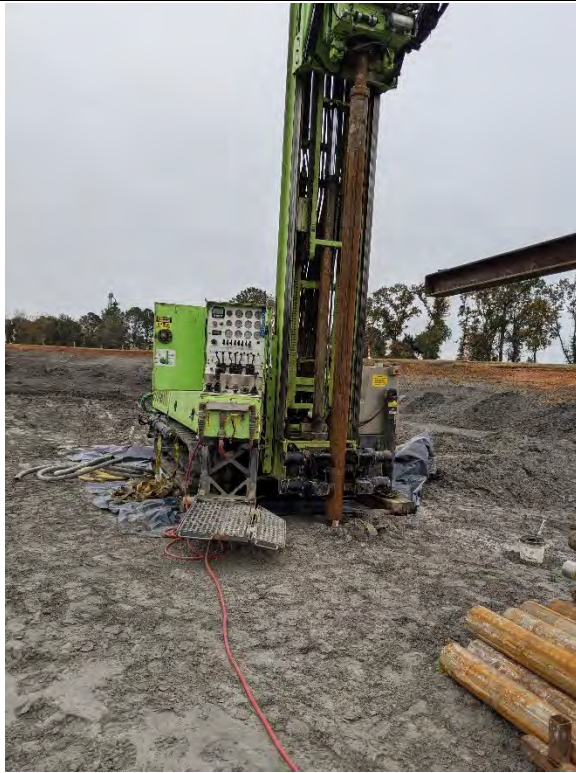
Wood Photographic Log	PZ-03R
Site: Plant Mitchell, Albany, Georgia	3
Photographer: Daniel Howard	Date: 12/17/20

Setup drill rig on well to begin overdrilling well to abandon well.

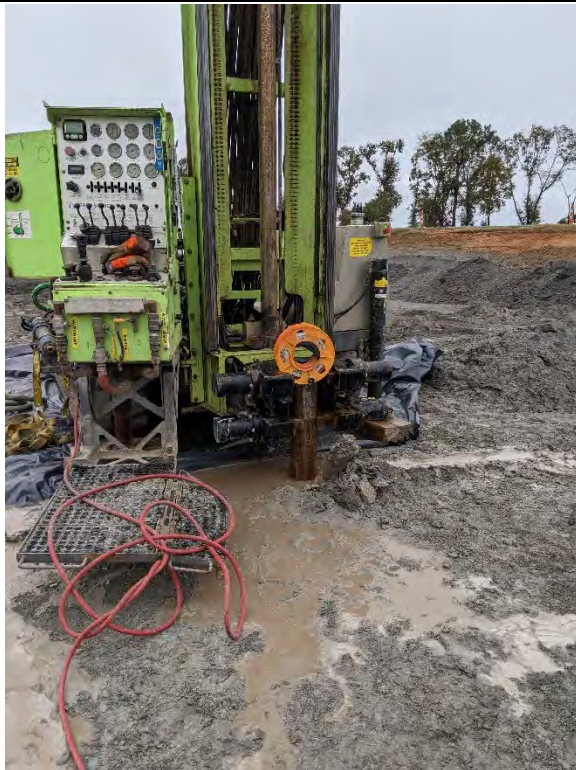
Wood Photographic Log	PZ-03R
Site: Plant Mitchell, Albany, Georgia	4
Photographer: Daniel Howard	Date: 12/17/20

Two-inch inner casing of well overdrilled with 6 inch auger down to 53 ft.

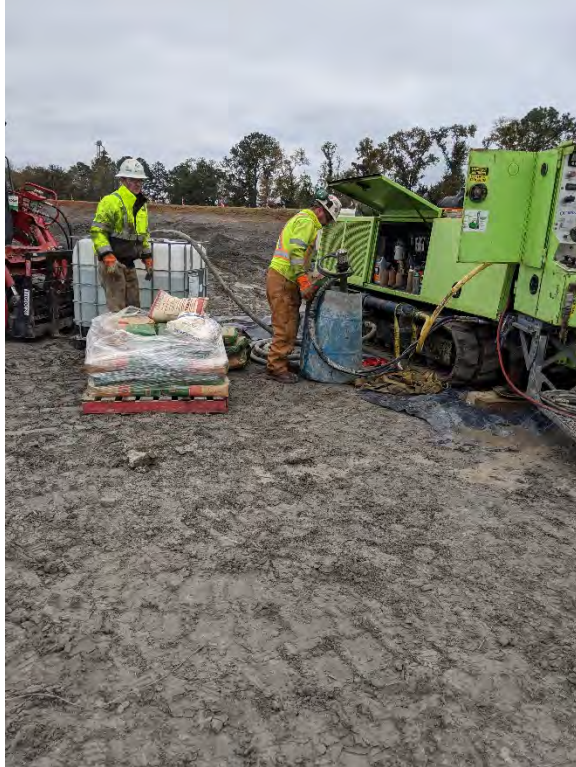
Wood Photographic Log	PZ-03R
Site: Plant Mitchell, Albany, Georgia	5
Photographer: Daniel Howard	Date: 12/17/20

Mixing grout to backfill borehole to bottom of ash pond. Approximately 26.5 gallons

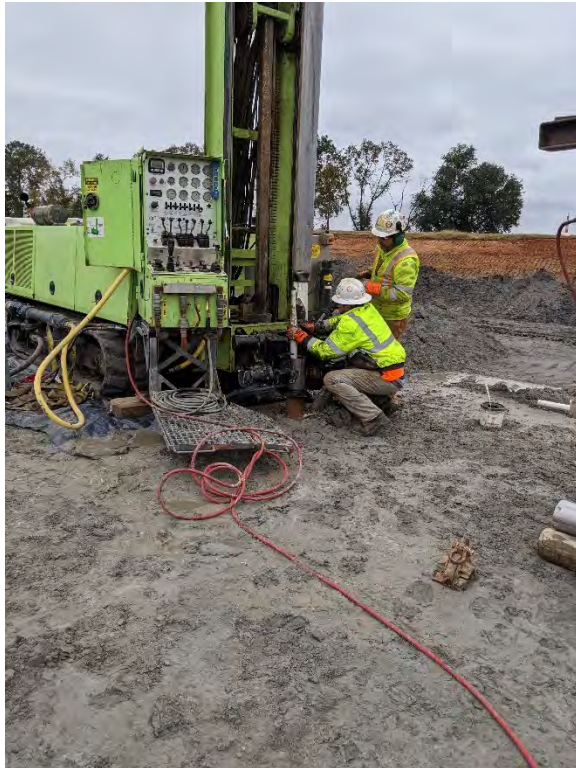
Wood Photographic Log	PZ-03R
Site: Plant Mitchell, Albany, Georgia	6
Photographer: Daniel Howard	Date: 12/17/20

Removing augers and well casing after backfilling with grout.

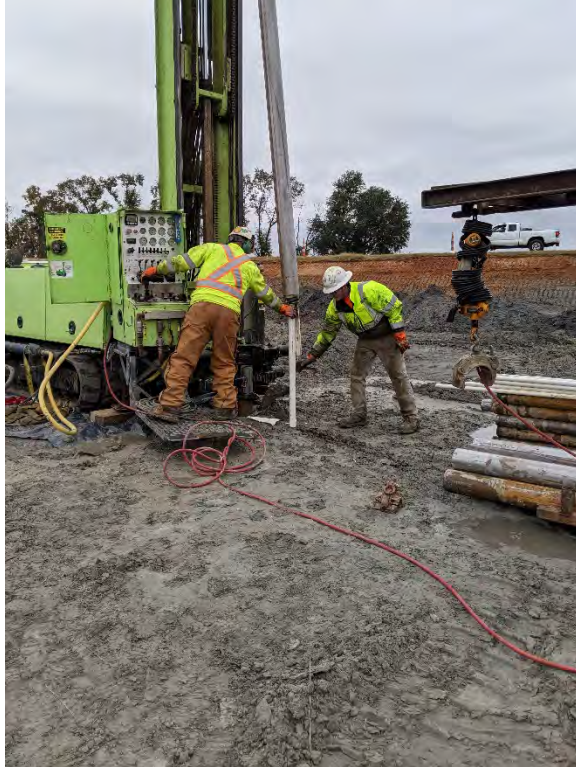
Wood Photographic Log	PZ-03R
Site: Plant Mitchell, Albany, Georgia	7
Photographer: Daniel Howard	Date: 12/17/20

Removing final auger and 2-inch casing from overdrilled well.

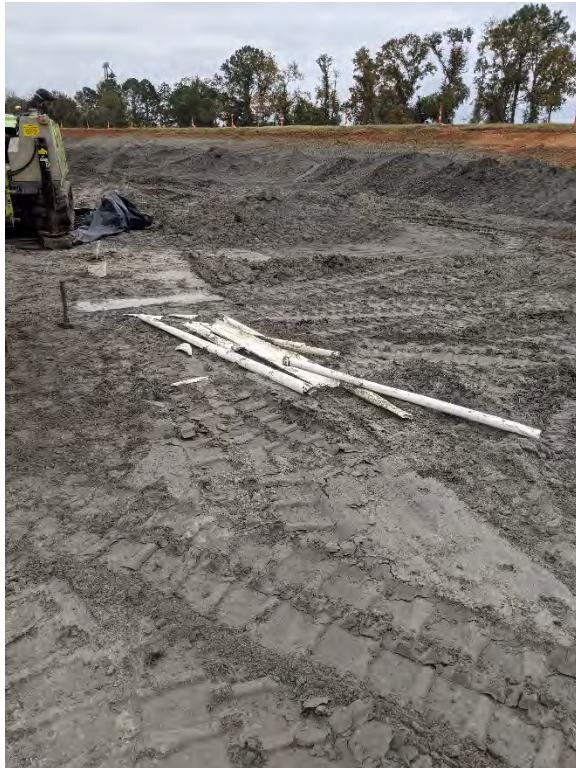
Wood Photographic Log	PZ-03R
Site: Plant Mitchell, Albany, Georgia	8
Photographer: Daniel Howard	Date: 12/17/20

PVC pipe removed from well.

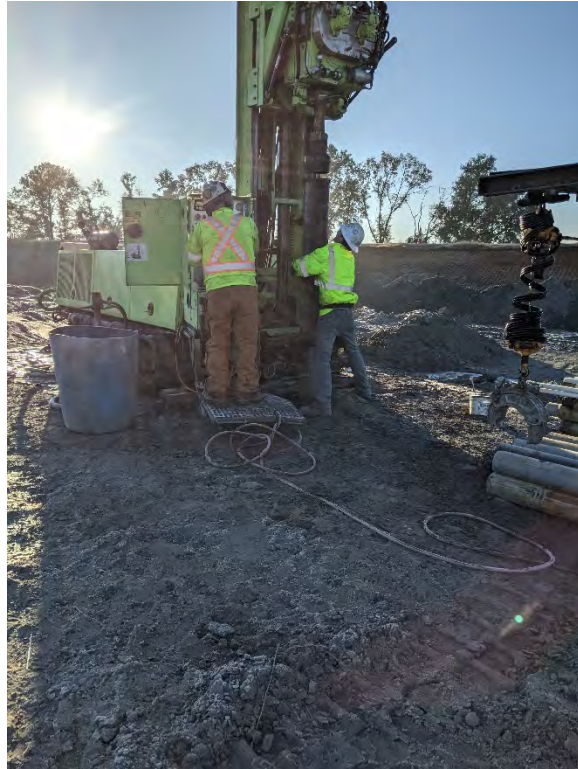
Wood Photographic Log	PZ-03R
Site: Plant Mitchell, Albany, Georgia	9
Photographer: Daniel Howard	Date: 12/18/20

Overdrilling outer casing with 9-inch augers in upper 25 ft of the well down to bottom of ash pond.

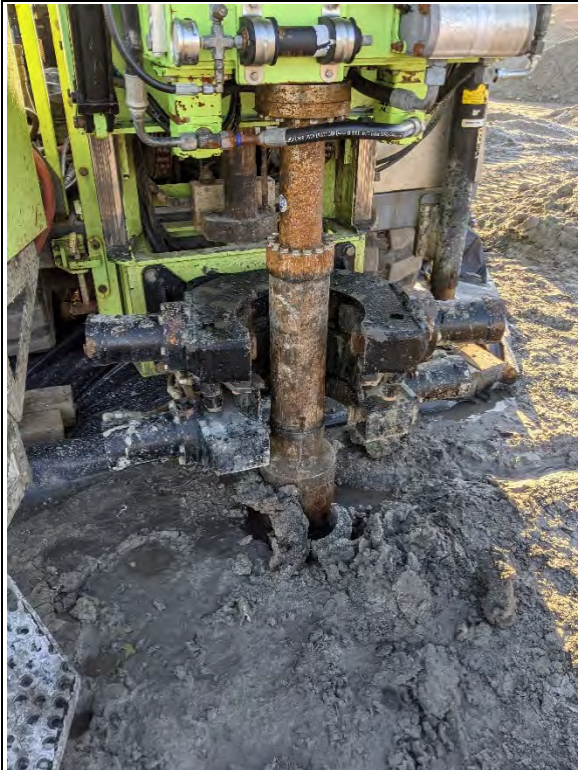
Wood Photographic Log	PZ-03R
Site: Plant Mitchell, Albany, Georgia	10
Photographer: Daniel Howard	Date: 12/18/20

Drilled down to 25 ft. to bottom of ash pond.

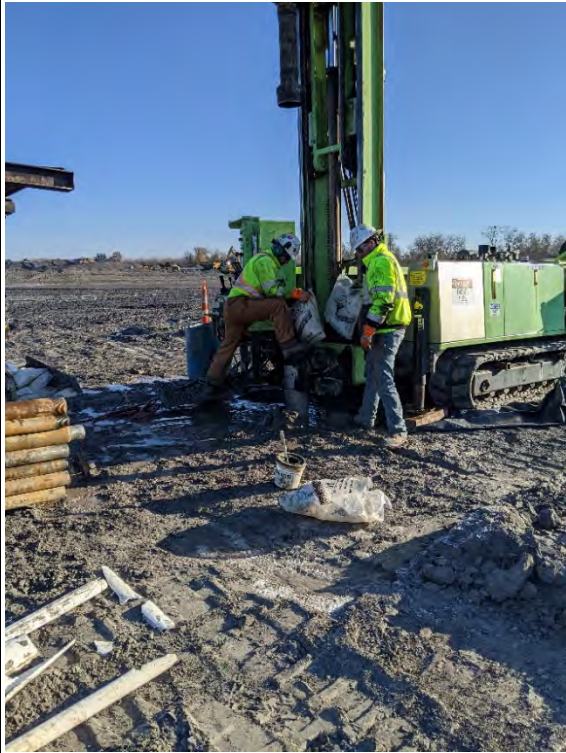
Wood Photographic Log	PZ-03R
Plant Mitchell, Albany, Georgia	11
Photographer: Daniel Howard	Date: 12/18/20

Backfilling 25 ft., 9-inch borehole through ash with sand.

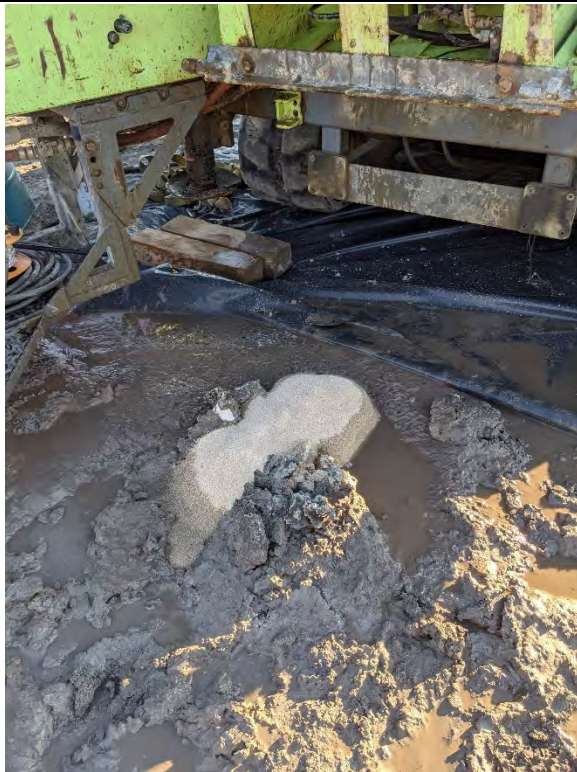
Wood Photographic Log	PZ-03R
Site: Plant Mitchell, Albany, Georgia	12
Photographer: Daniel Howard	Date: 12/18/20

Finished backfilling 25 ft, 9-inch borehole from bottom of ash pond to ground surface.

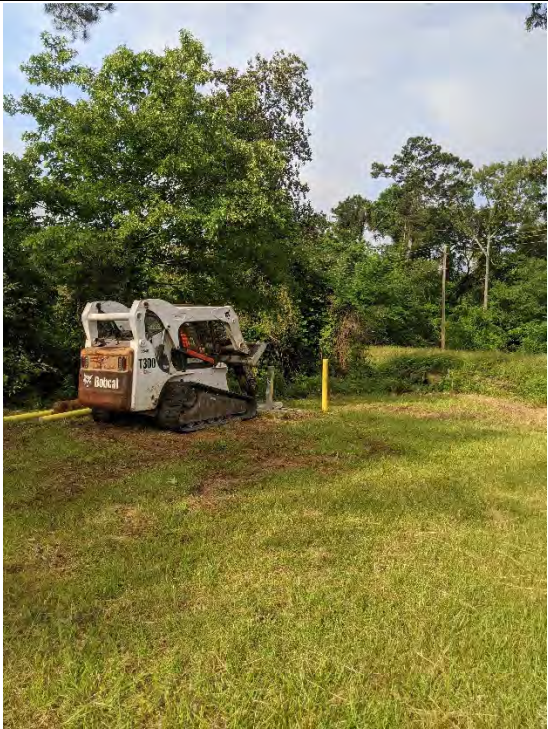
Wood Photographic Log	PZ-26
Site: Plant Mitchell, Albany Georgia	1
Photographer: Daniel Howard	Date: 5/3/2021

Removal of concrete pad and bollards.

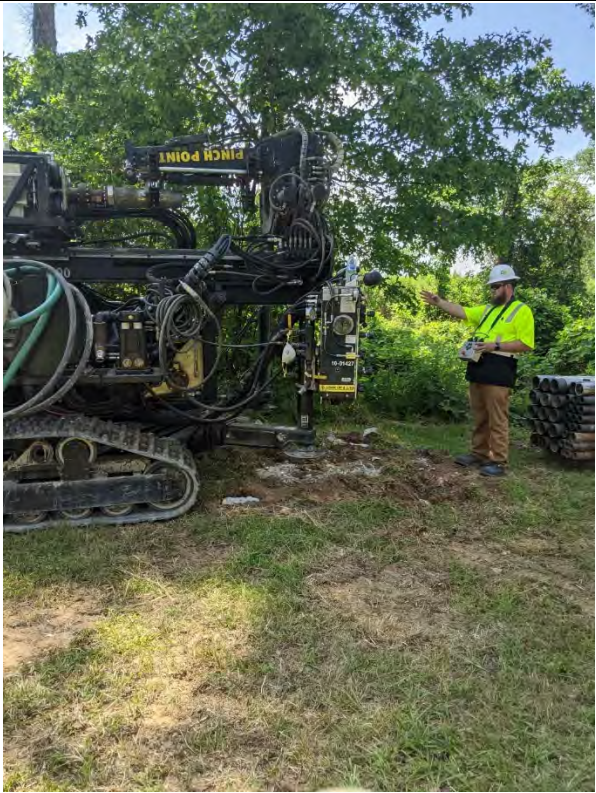
Wood Photographic Log	PZ-26
Site: Plant Mitchell, Albany, Georgia	2
Photographer: Daniel Howard	Date: 5/3/2021

Setup of drill rig on well.

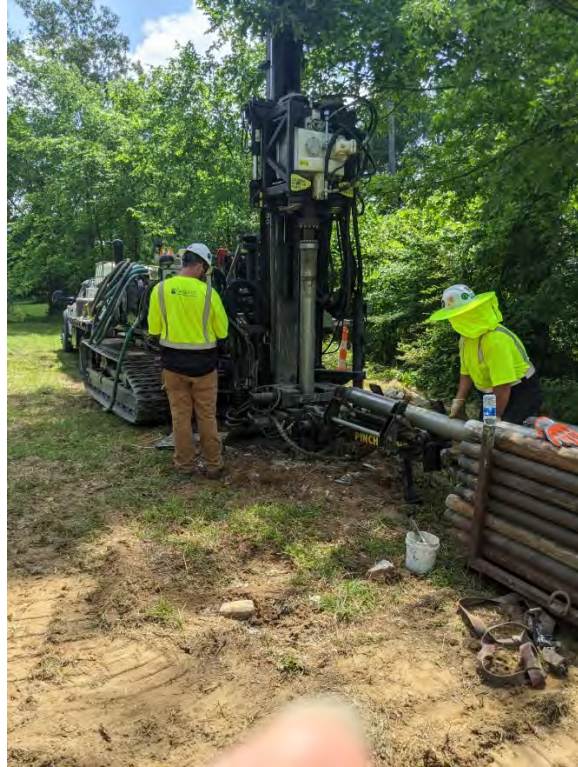
Wood Photographic Log	PZ-26
Site: Plant Mitchell, Albany, Georgia	3
Photographer: Daniel Howard	Date: 5/3/2021

Begin overdrilling well to abandon well.

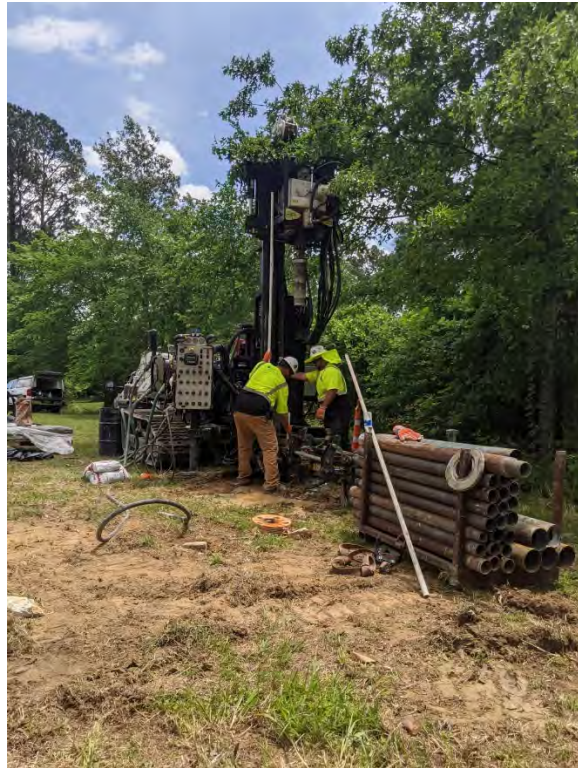
Wood Photographic Log	PZ-26
Site: Plant Mitchell, Albany, Georgia	4
Photographer: Daniel Howard	Date: 5/3/2021

Two-inch inner casing of well overdrilled with 6-inch auger.

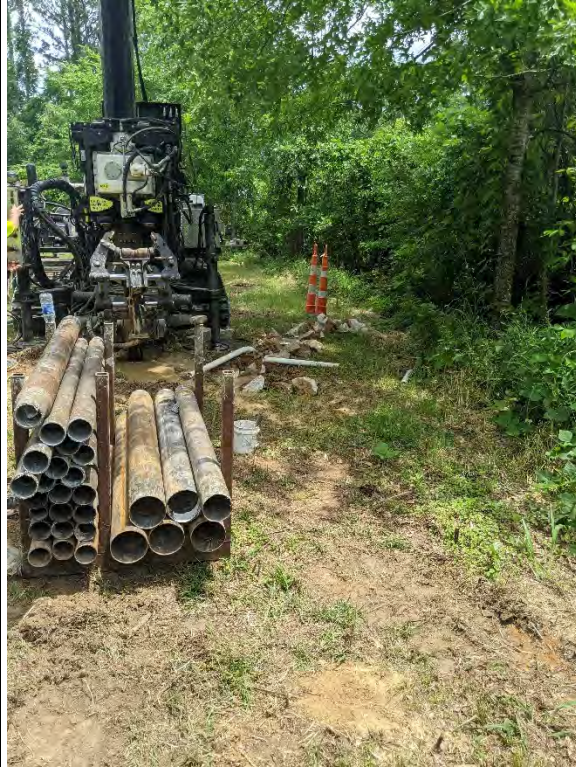
Wood Photographic Log	PZ-26
Site: Plant Mitchell, Albany, Georgia	5
Photographer: Daniel Howard	Date: 5/3/2021

Removing part of well casing.

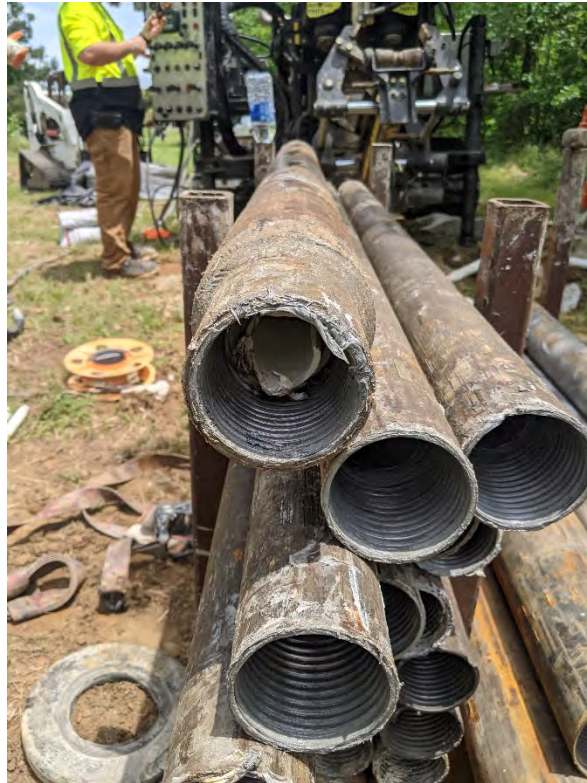
Wood Photographic Log	PZ-26
Site: Plant Mitchell, Albany, Georgia	6
Photographer: Daniel Howard	Date: 5/3/2021

Part of casing inside auger.

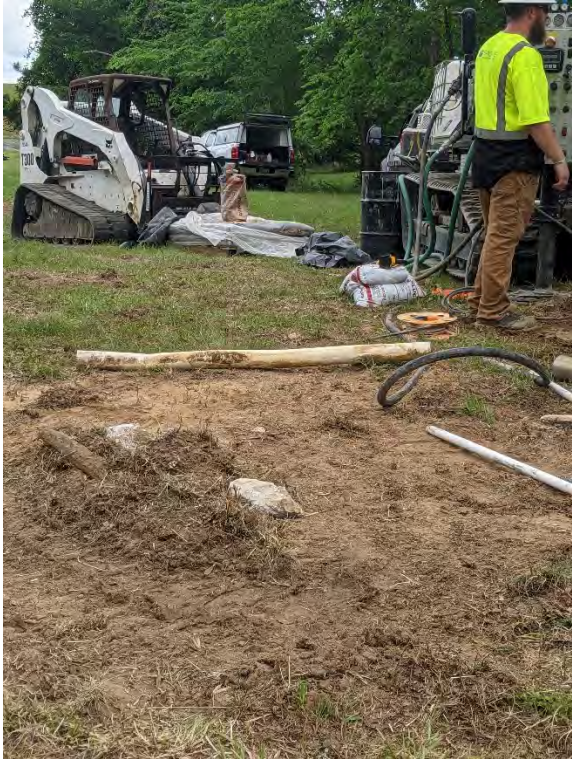
Wood Photographic Log	PZ-26
Site: Plant Mitchell, Albany, Georgia	7
Photographer: Daniel Howard	Date: 5/3/2021

Well screen removed from bottom of well.

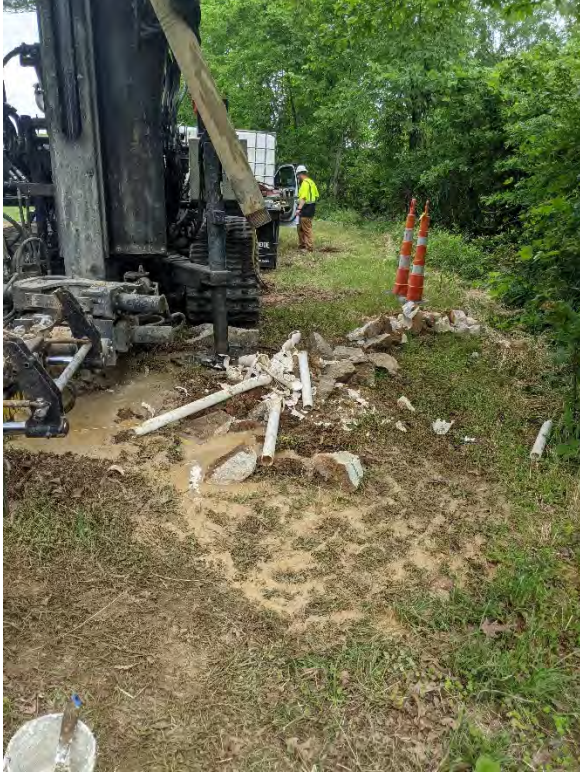
Wood Photographic Log	PZ-26
Site: Plant Mitchell, Albany, Georgia	8
Photographer: Daniel Howard	Date: 5/3/2021

Complete well casing removed from well.

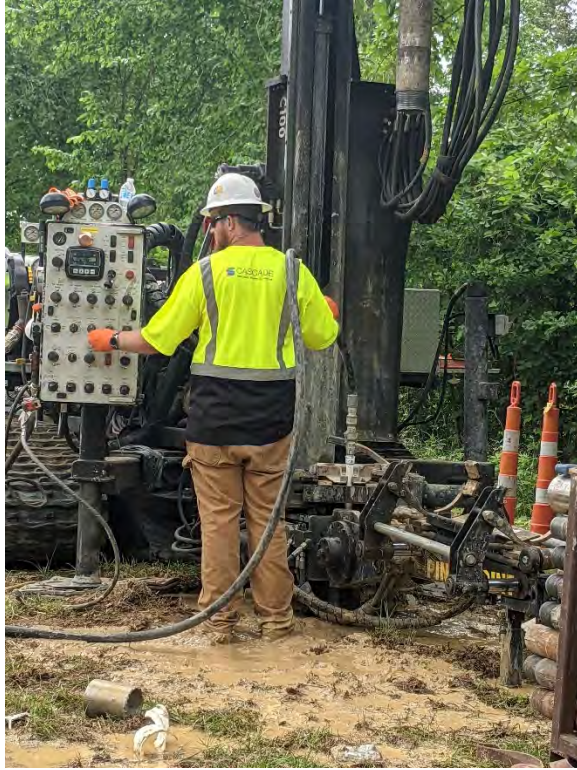
Wood Photographic Log	PZ-26
Site: Plant Mitchell, Albany, Georgia	9
Photographer: Daniel Howard	Date: 5/3/2021

Grouting up borehole with tremie pipe.

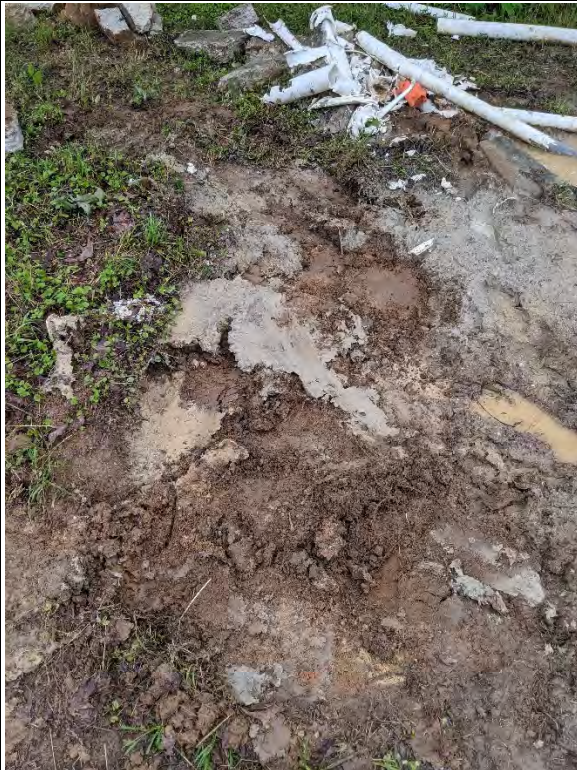
Wood Photographic Log	PZ-26
Site: Plant Mitchell, Albany, Georgia	10
Photographer: Daniel Howard	Date: 5/5/2021

Overdrilled well grouted up to ground surface.

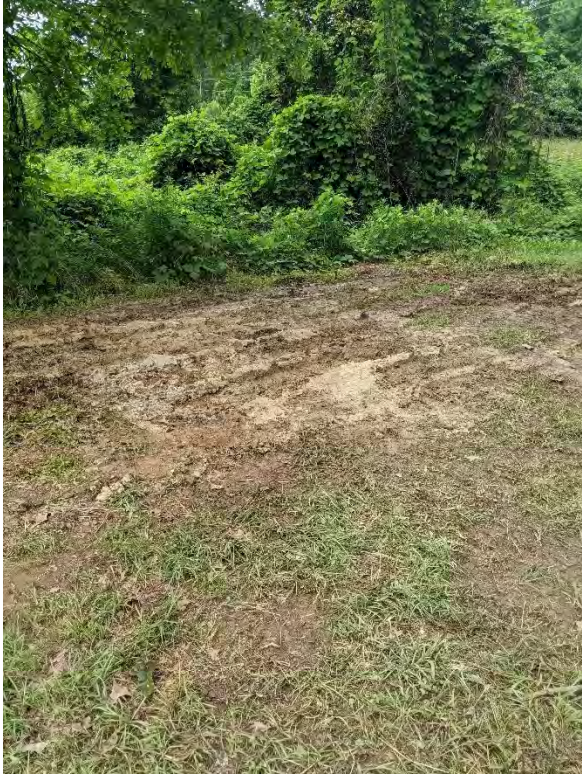
Wood Photographic Log	PZ-26
Plant Mitchell, Albany, Georgia	11
Photographer: Daniel Howard	Date: 5/5/2021

Area after debris removal.
