Lloyd Shoals Hydroelectric Project (FERC No. 2336-094)
Relicensing Study Reports

STUDY REPORT

GEOLOGY AND SOILS

LLOYD SHOALS HYDROELECTRIC PROJECT
(FERC No. 2336)

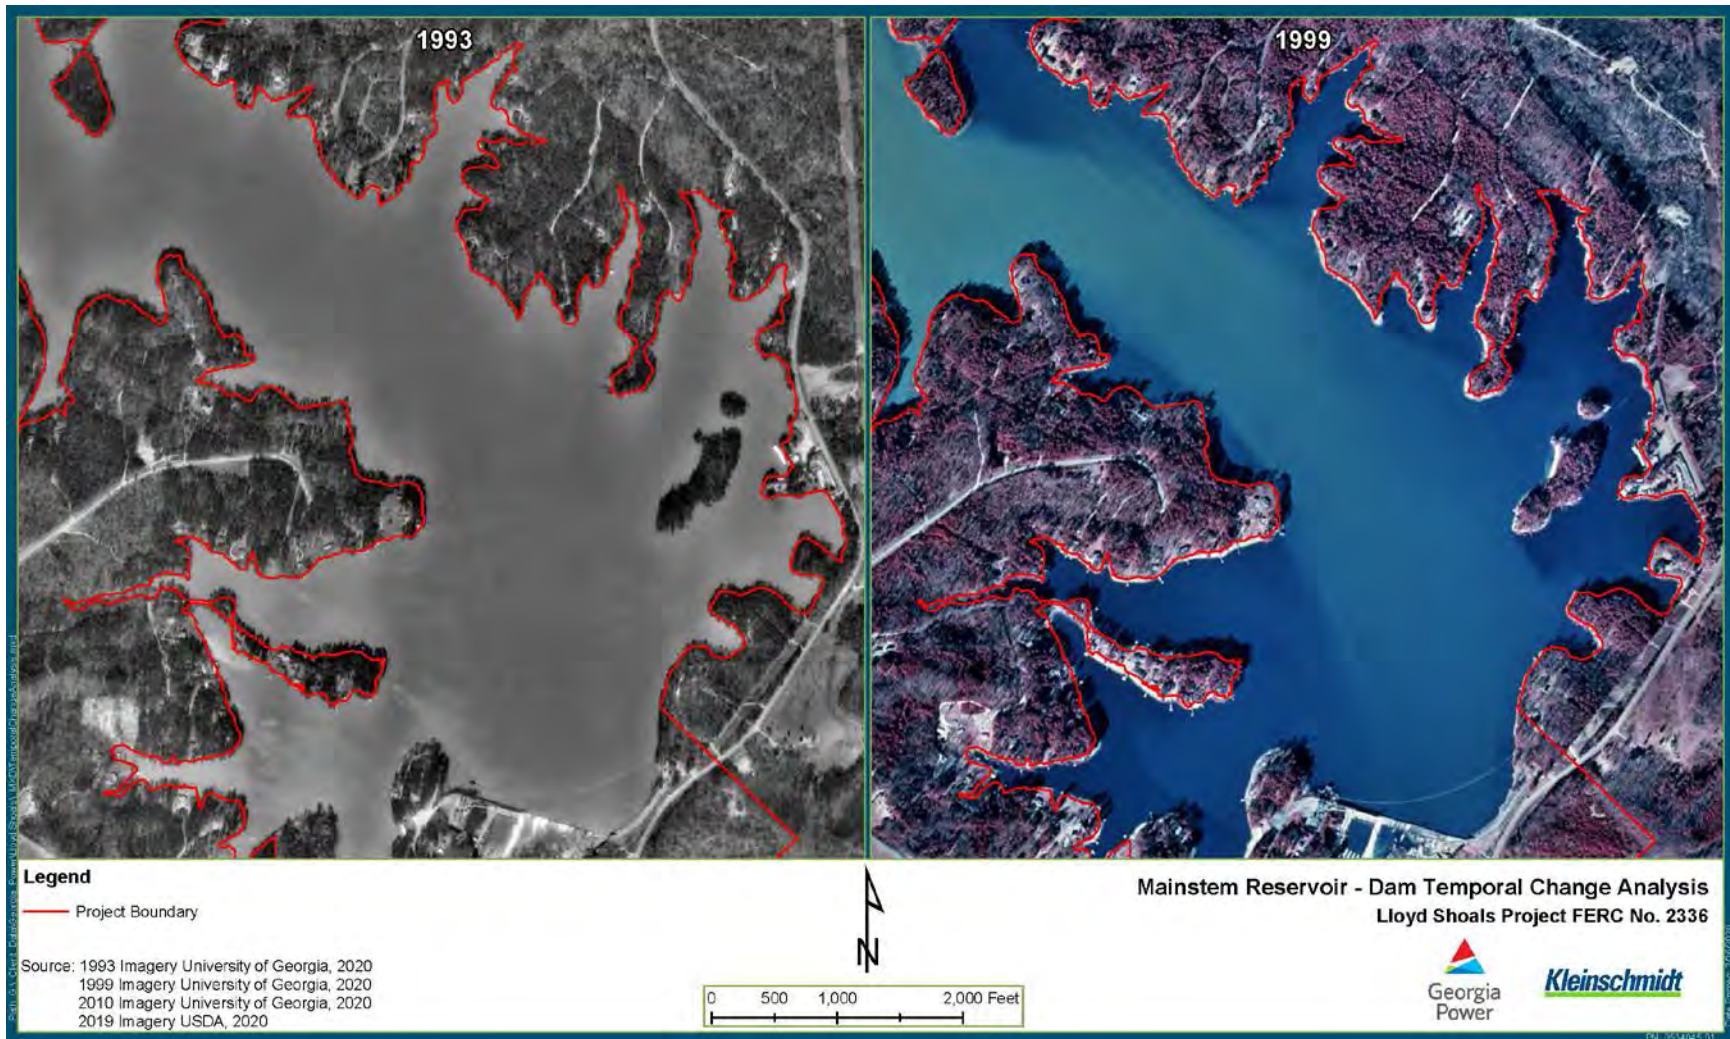
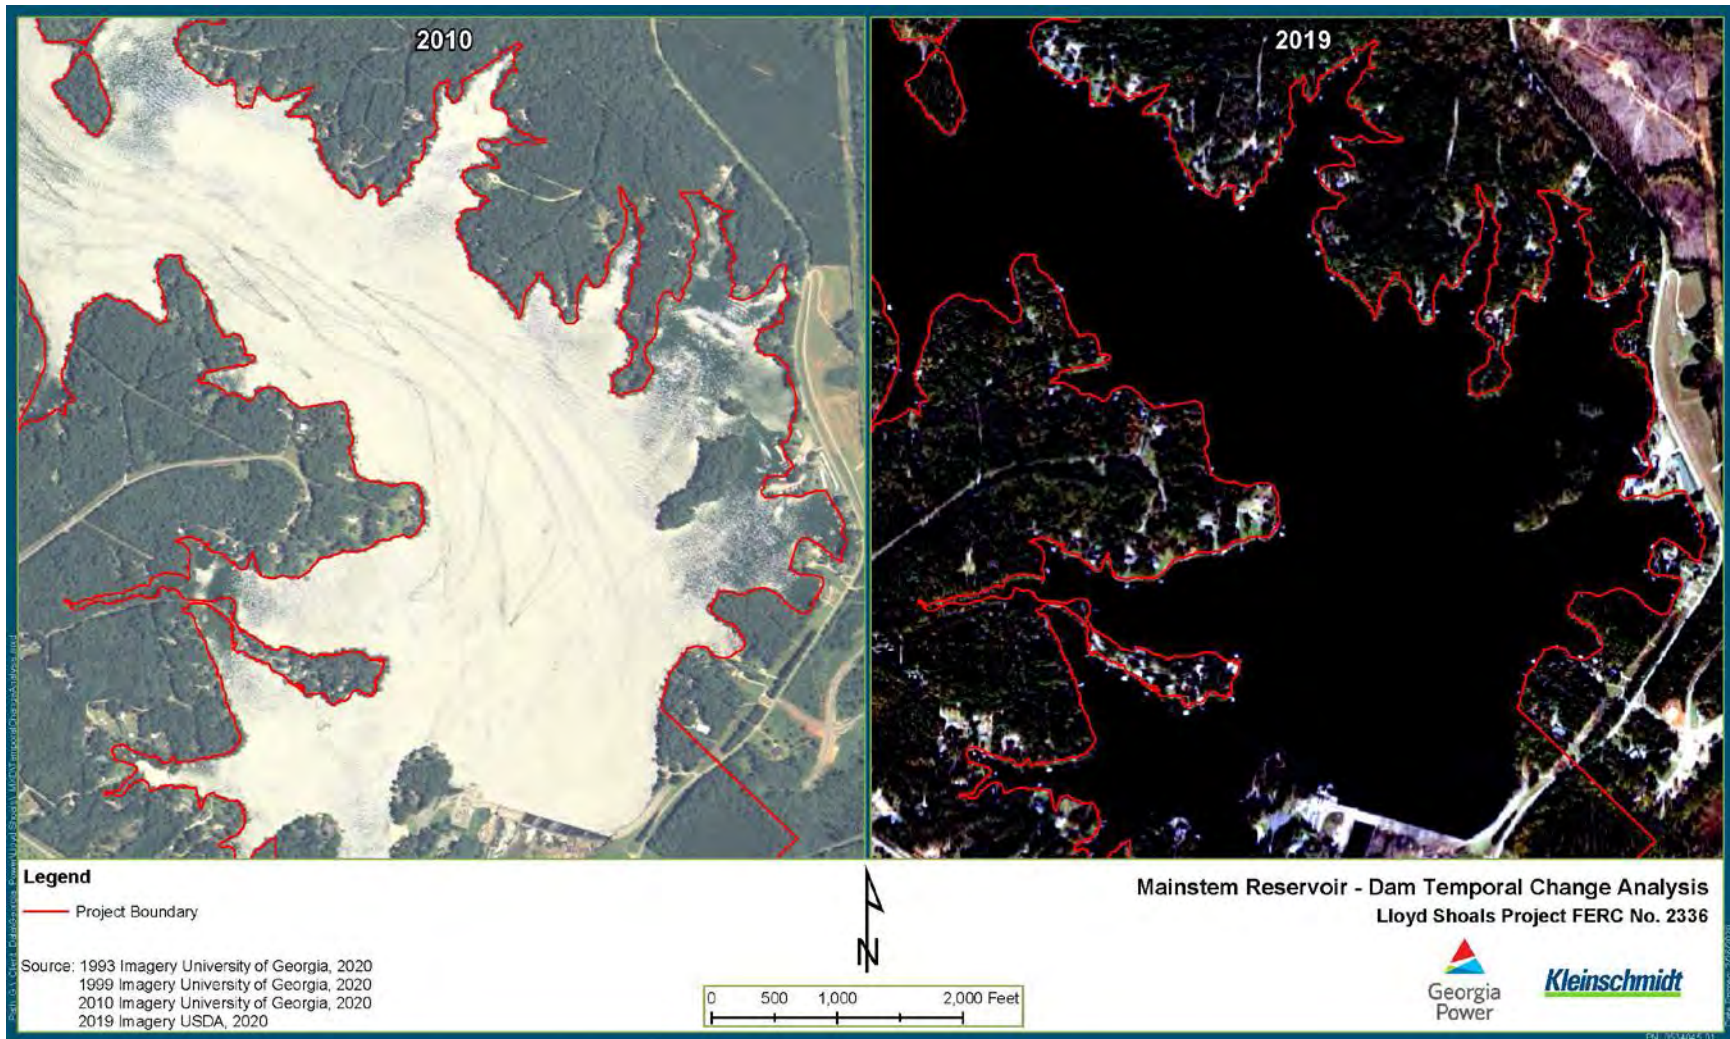
FIGURE 13 SHORELINE TEMPORAL CHANGE ANALYSIS MAINSTEM RESERVOIR - DAM

Figure 13 and Figure 14 compare the 1993, 1999, 2010, and 2019 aerial imagery of the mainstem reservoir near the dam. The shoreline configuration within this reach has shown little to no change in overall configuration since 1993. The area has experienced some additional land clearing in upland areas outside of the project boundary, namely a tract of land outside of the project boundary in the northeast corner of the map area. There has also been an increase in the number of residential homes and docks constructed in the area. Of the seven shoreline survey sites in this area, five were landscaped, one landscaped-natural, and one natural. Despite the shoreline development in the area, overall shoreline configuration and stability have been maintained. This is in part due to effective structural stabilization practices, as inventoried during the shoreline survey. Only site MR-13 had less than 75 percent of its shoreline fortified with shoreline stabilization; it had 15 percent stabilized. Section MR-09 was the only section in the area noted as having any active erosion.

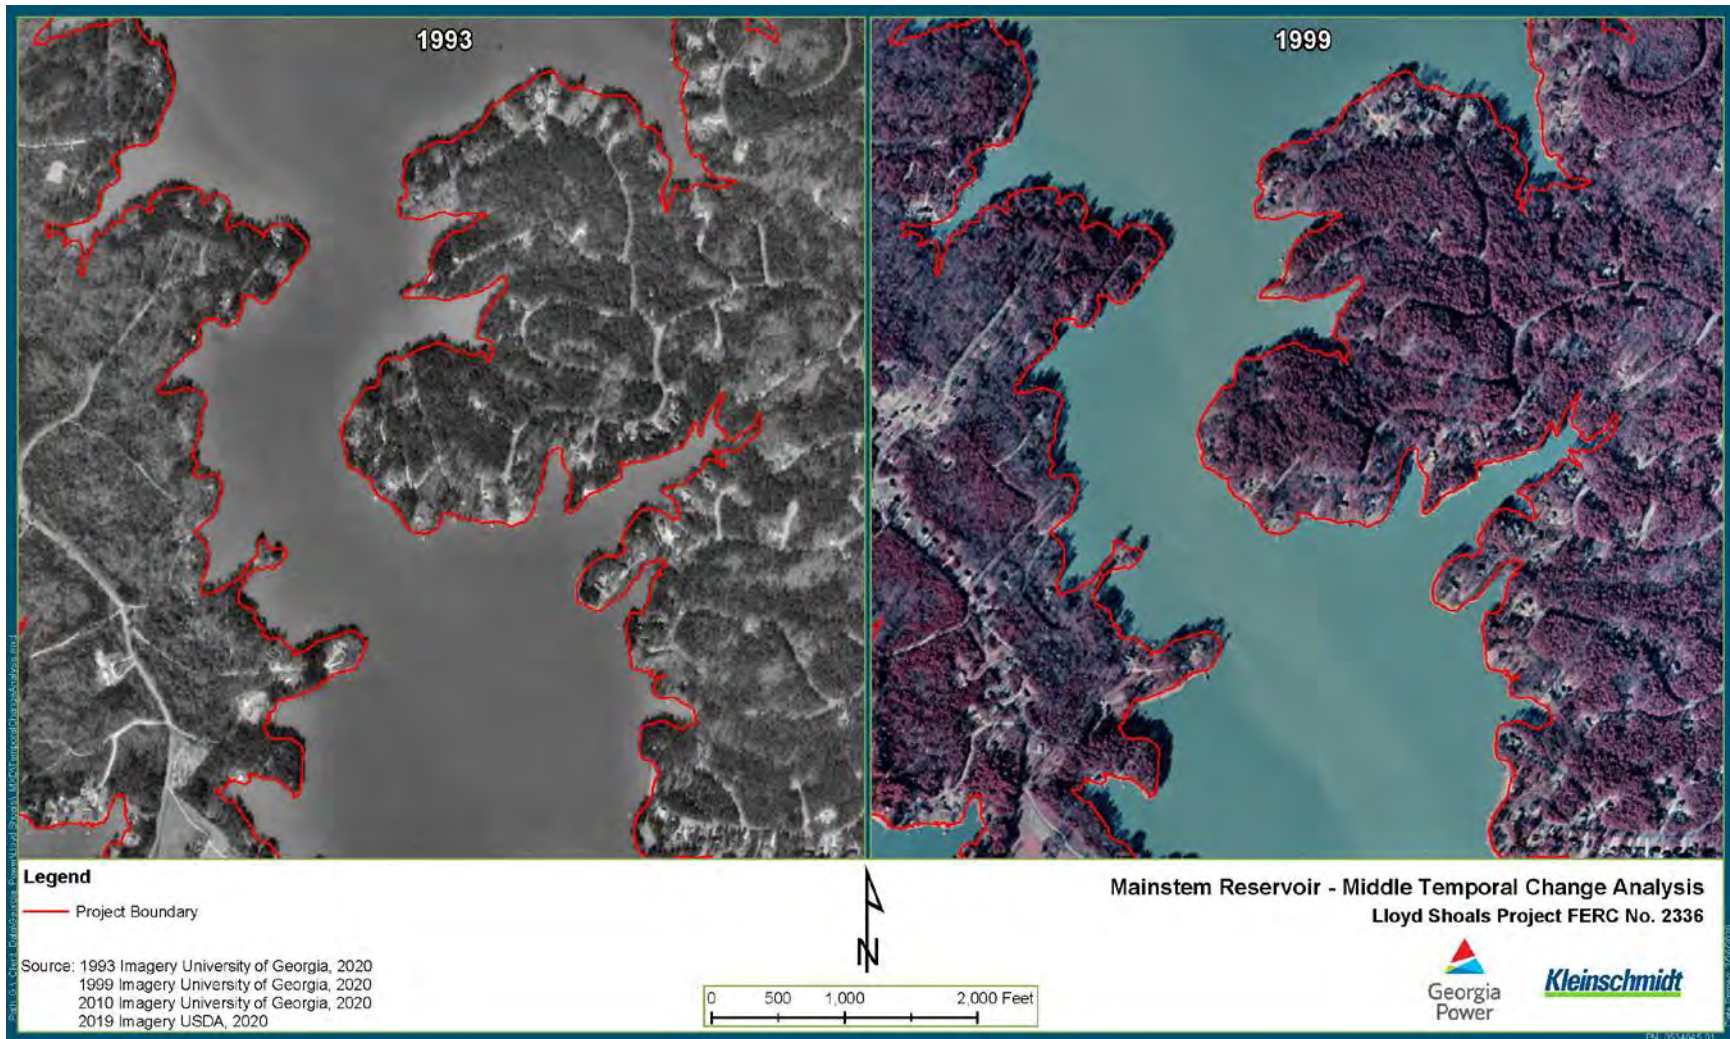
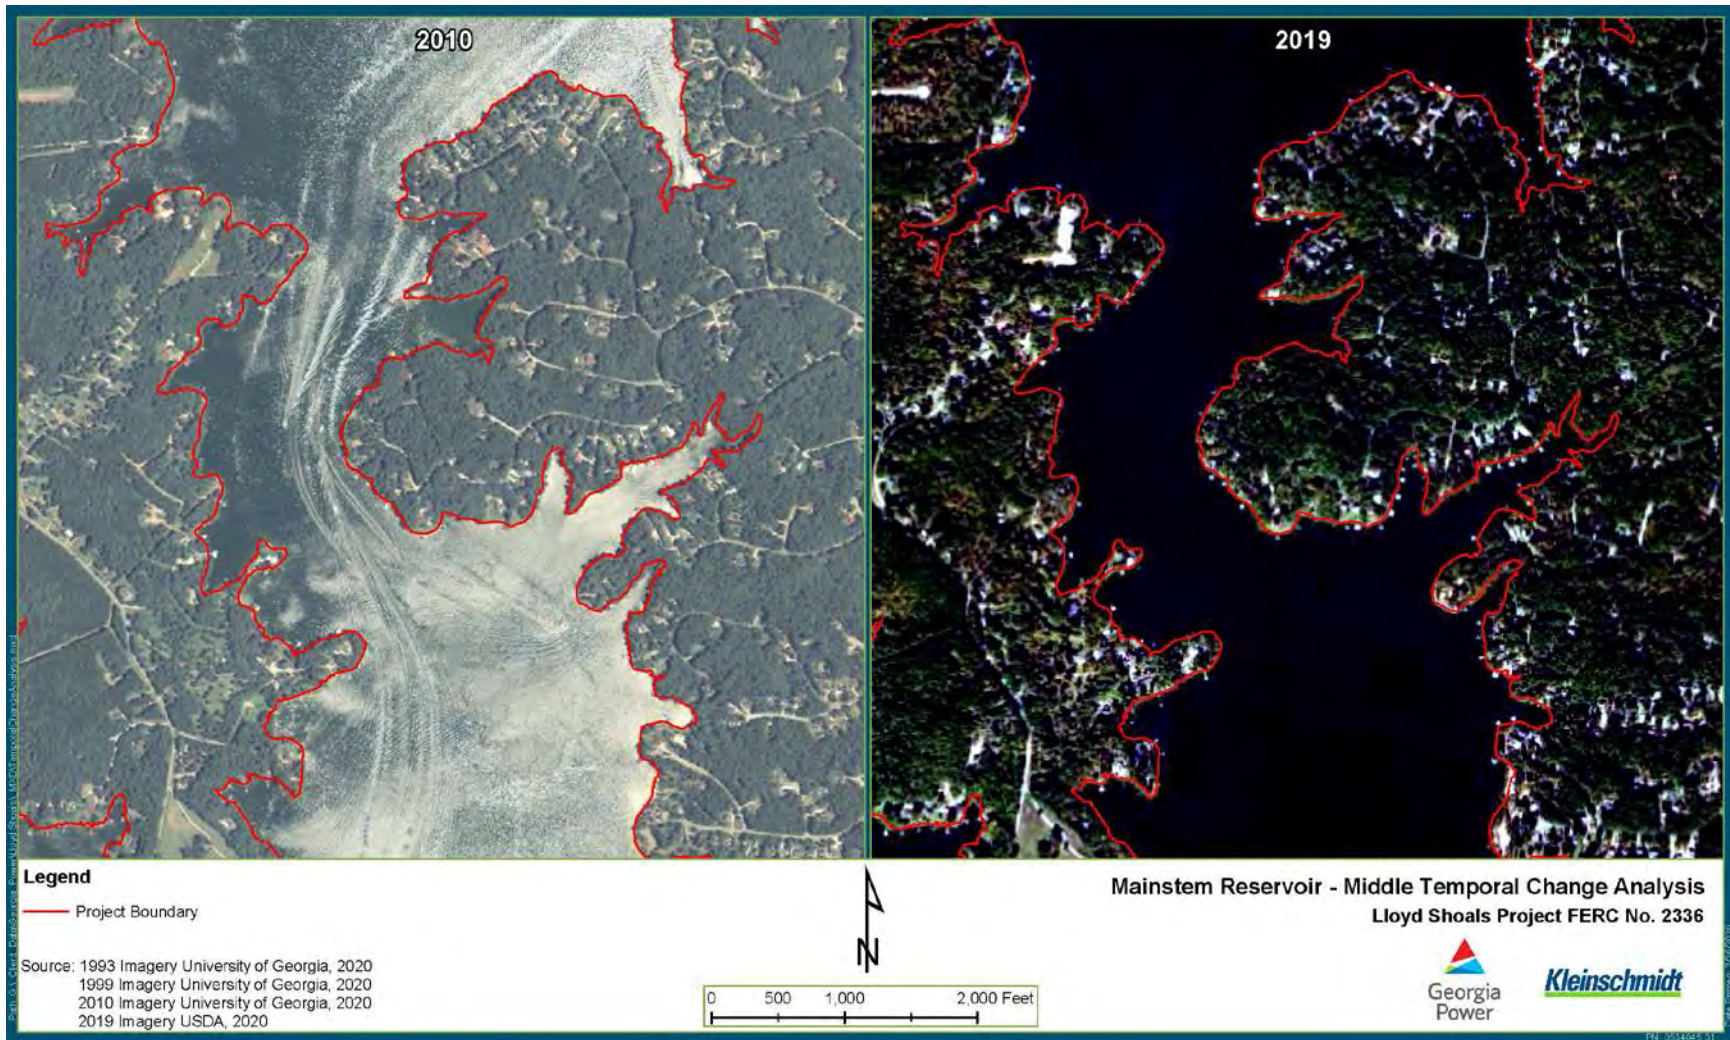
FIGURE 15 SHORELINE TEMPORAL CHANGE ANALYSIS MAINSTEM RESERVOIR – MIDDLE

Figure 15 and Figure 16 compare the 1993, 1999, 2010, and 2019 aerial imagery of the mainstem reservoir toward the middle of Lake Jackson. Despite significant residential construction in this reach, the shoreline configuration has remained predominantly unchanged since 1993. Most of the home construction along both the eastern and western banks appears to have occurred between 1999 and 2010. Land clearing in upland areas in this reach appears to have been solely for residential construction with no signs of any logging operations. Dock/pier and shoreline stabilization construction has coincided with the residential construction. Of the five shoreline survey sites in this area, four were landscaped and one was landscaped-natural. All of the sites had greater than 50 percent shoreline stabilization; three had greater than 90 percent. One site, MR-02, had moderately unstable banks. Being along the mainstem shoreline, the site was exposed to significant wave action from watercraft and wind. Due to the use of shoreline structural stabilization practices, there was little evidence of shoreline change since 1993.

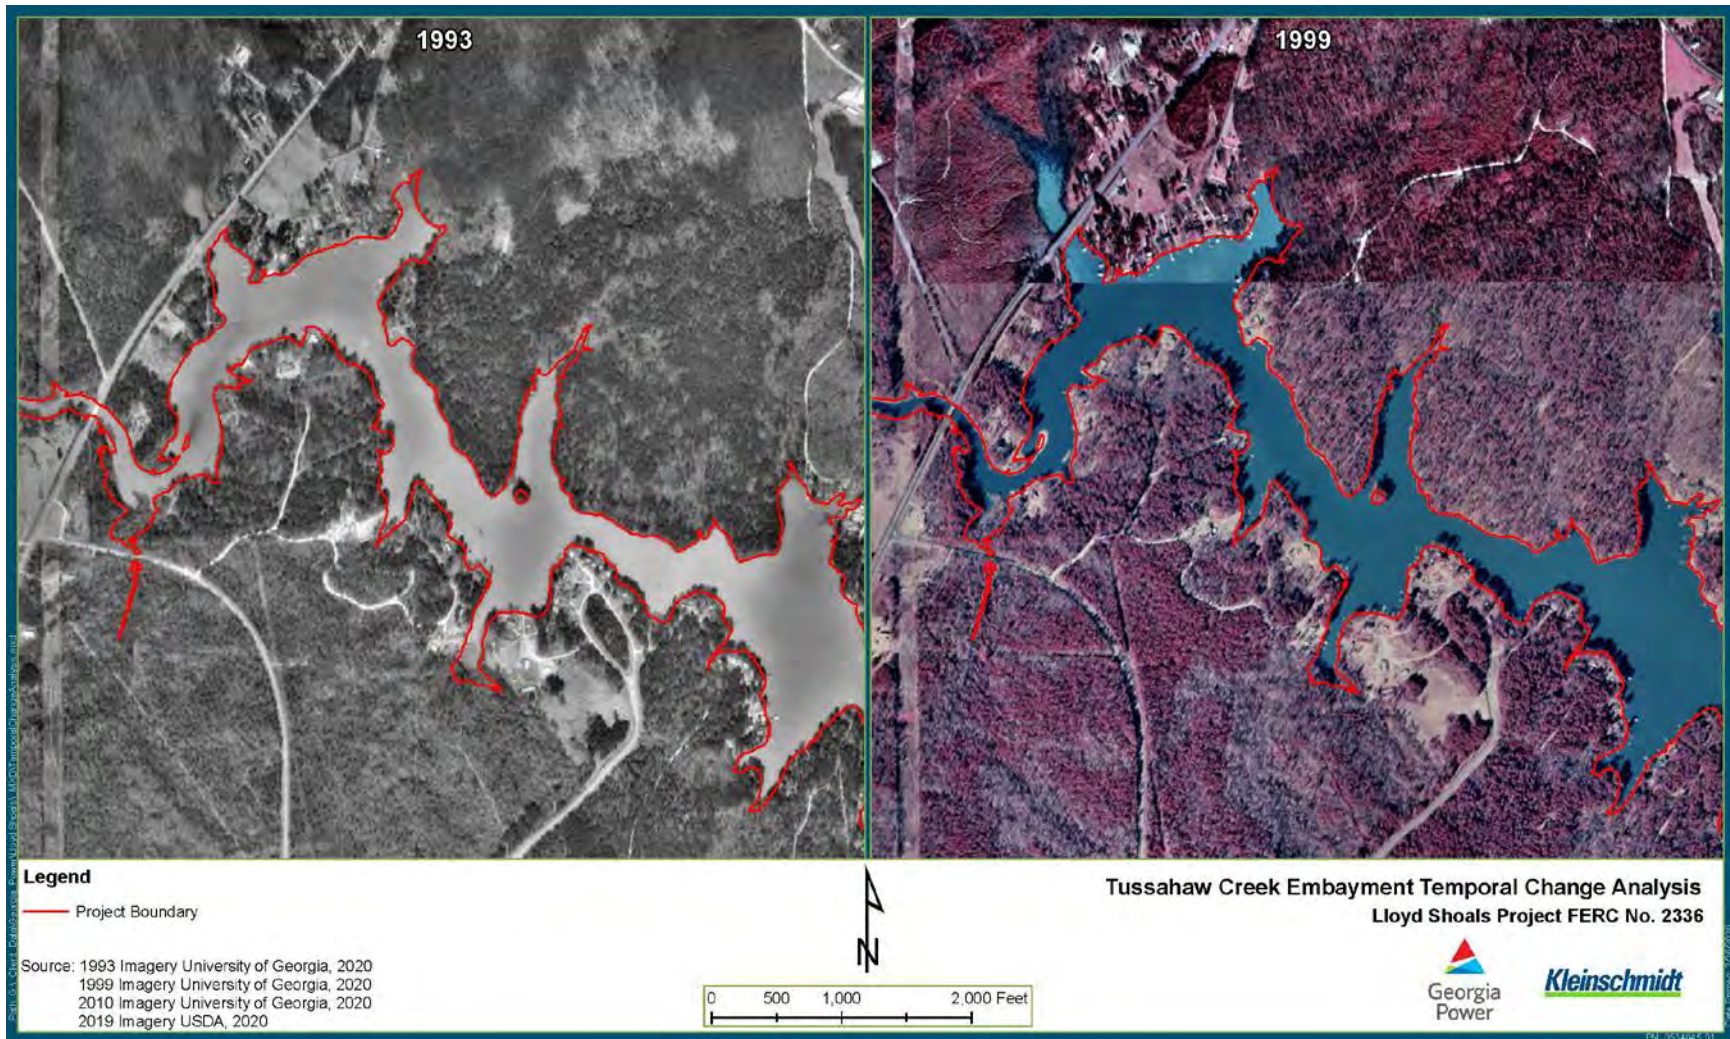
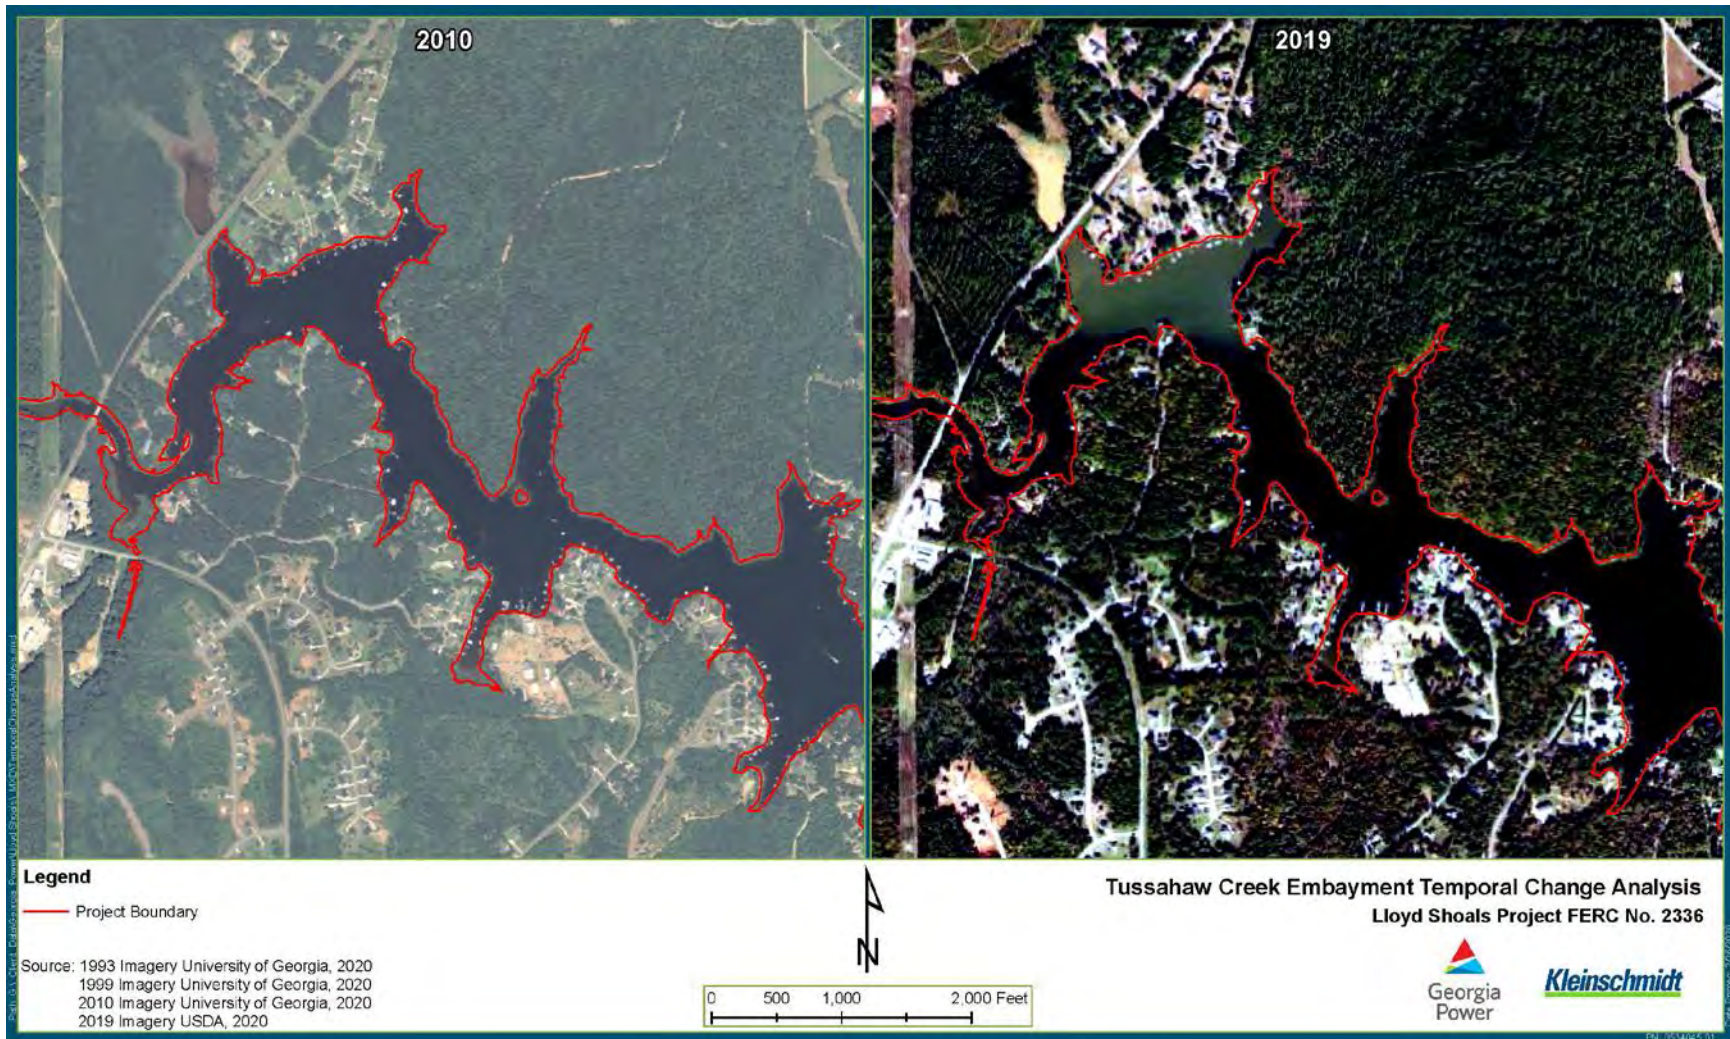
FIGURE 17 SHORELINE TEMPORAL CHANGE ANALYSIS TUSSAHAW CREEK

Figure 17 and Figure 18 compare the 1993, 1999, 2010, and 2019 aerial imagery of the Tussahaw Creek embayment. Shoreline and sedimentation in Tussahaw Creek have been moderately dynamic since 1993. Residential construction along the southern edge and portions

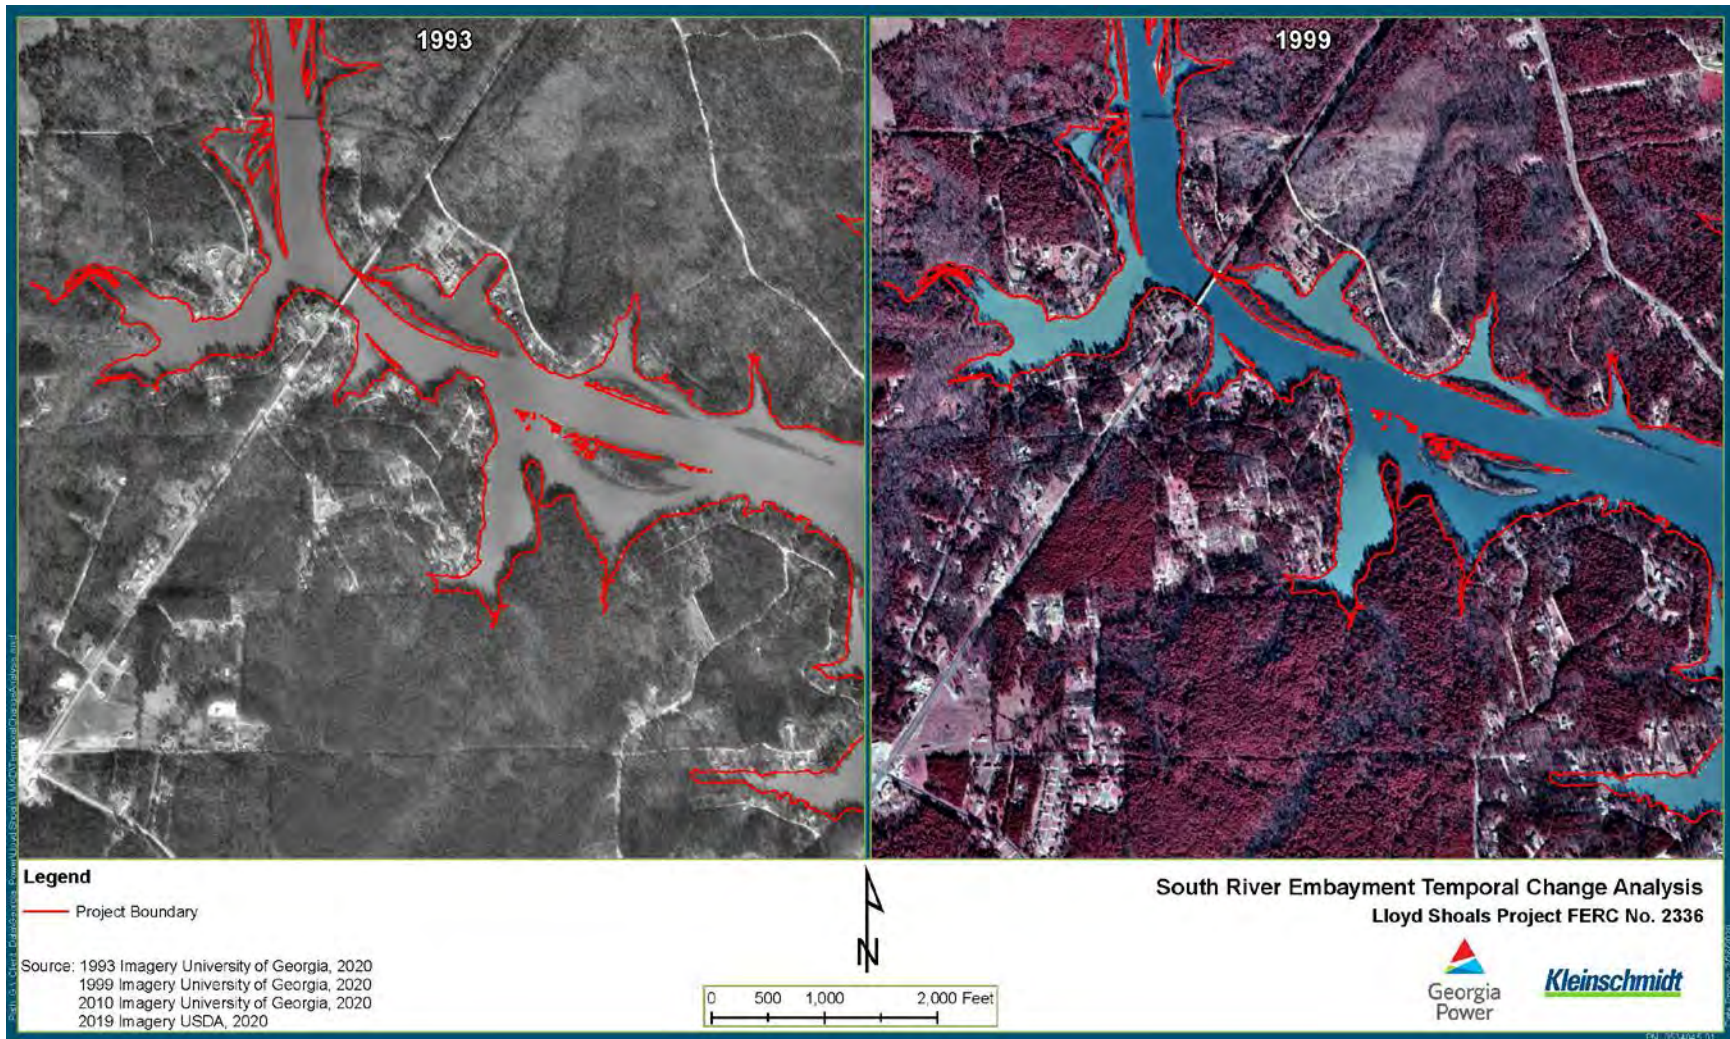
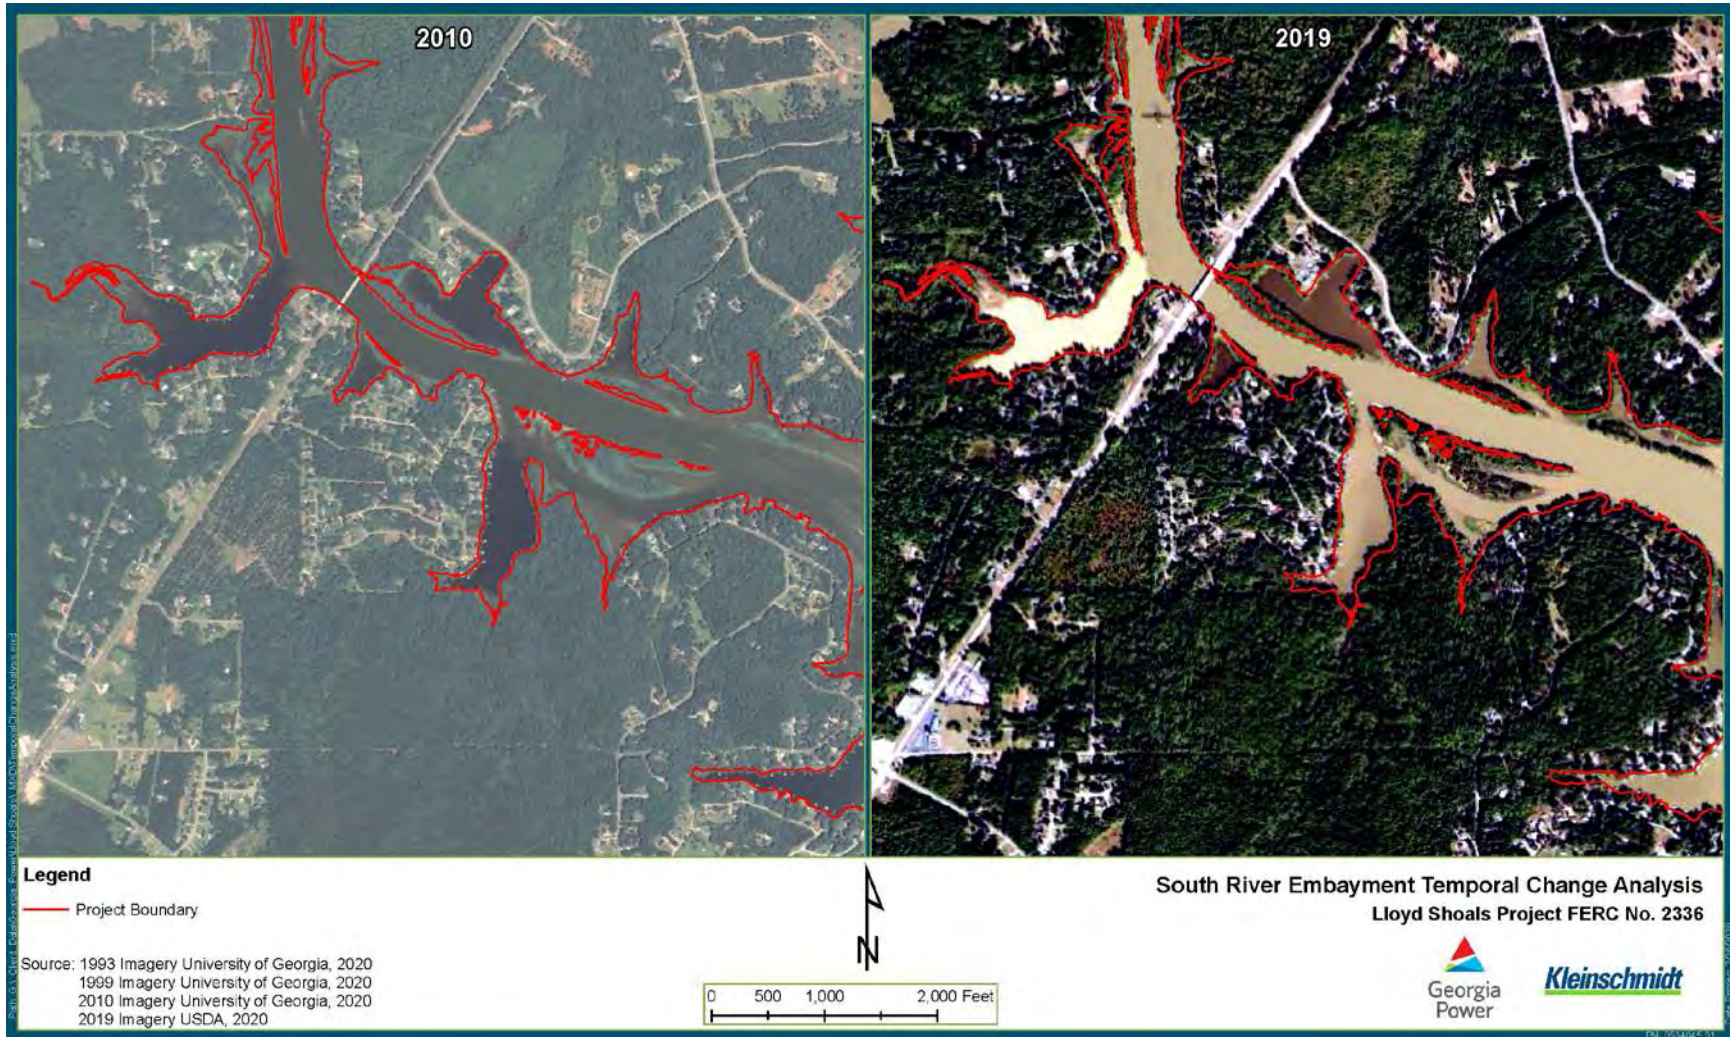
FIGURE 19 SHORELINE TEMPORAL CHANGE ANALYSIS SOUTH RIVER

Figure 19 and Figure 20 compare the 1993, 1999, 2010, and 2019 aerial imagery of the South River embayment. This section, which includes the Hwy 36 bridge crossing, represents one of the more dynamic reaches within the project boundary, as the configuration changes from a more riverine to lacustrine system. This transition results in more prevalent changes in natural sediment transport processes in the reach. Similar to other areas of the lake, residential construction has increased since 1993 but not to the same degree as other areas of the lake such as the mainstem reservoir and the Tussahaw Creek embayment. Logging or land clearing activities in upland forests have not been prevalent in this area. Of the two shoreline survey sites within this reach, one was landscaped-natural and the other natural. Neither had any shoreline structural stabilization practices. Both banks were rated as stable with substantial bank vegetative protection. Although “hard-bank” sections of the shoreline in this reach have remained stable, sedimentation along points, islands, and sandbars is prevalent. Ongoing sediment transport and deposition processes are evident visually by the formation of new islands and the reshaping of point-bars in the reservoir. This is a result of the high sediment load received by the South River due to upstream development (Section 3.2.1).

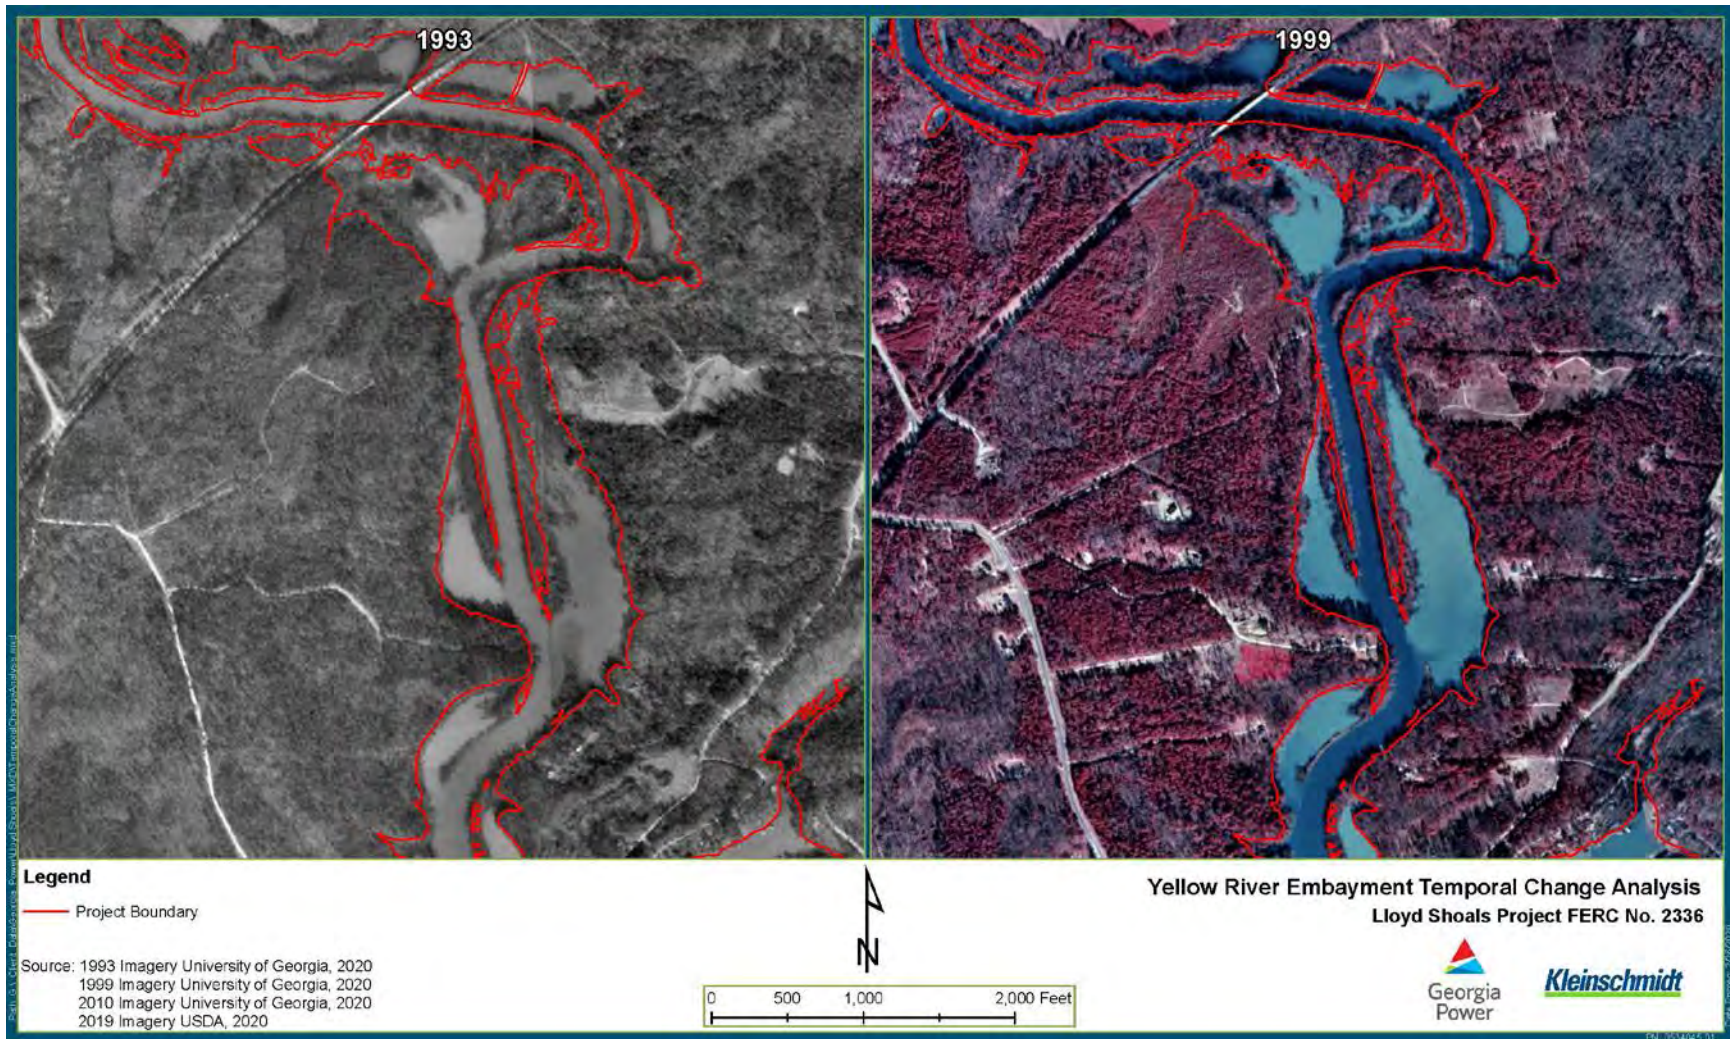
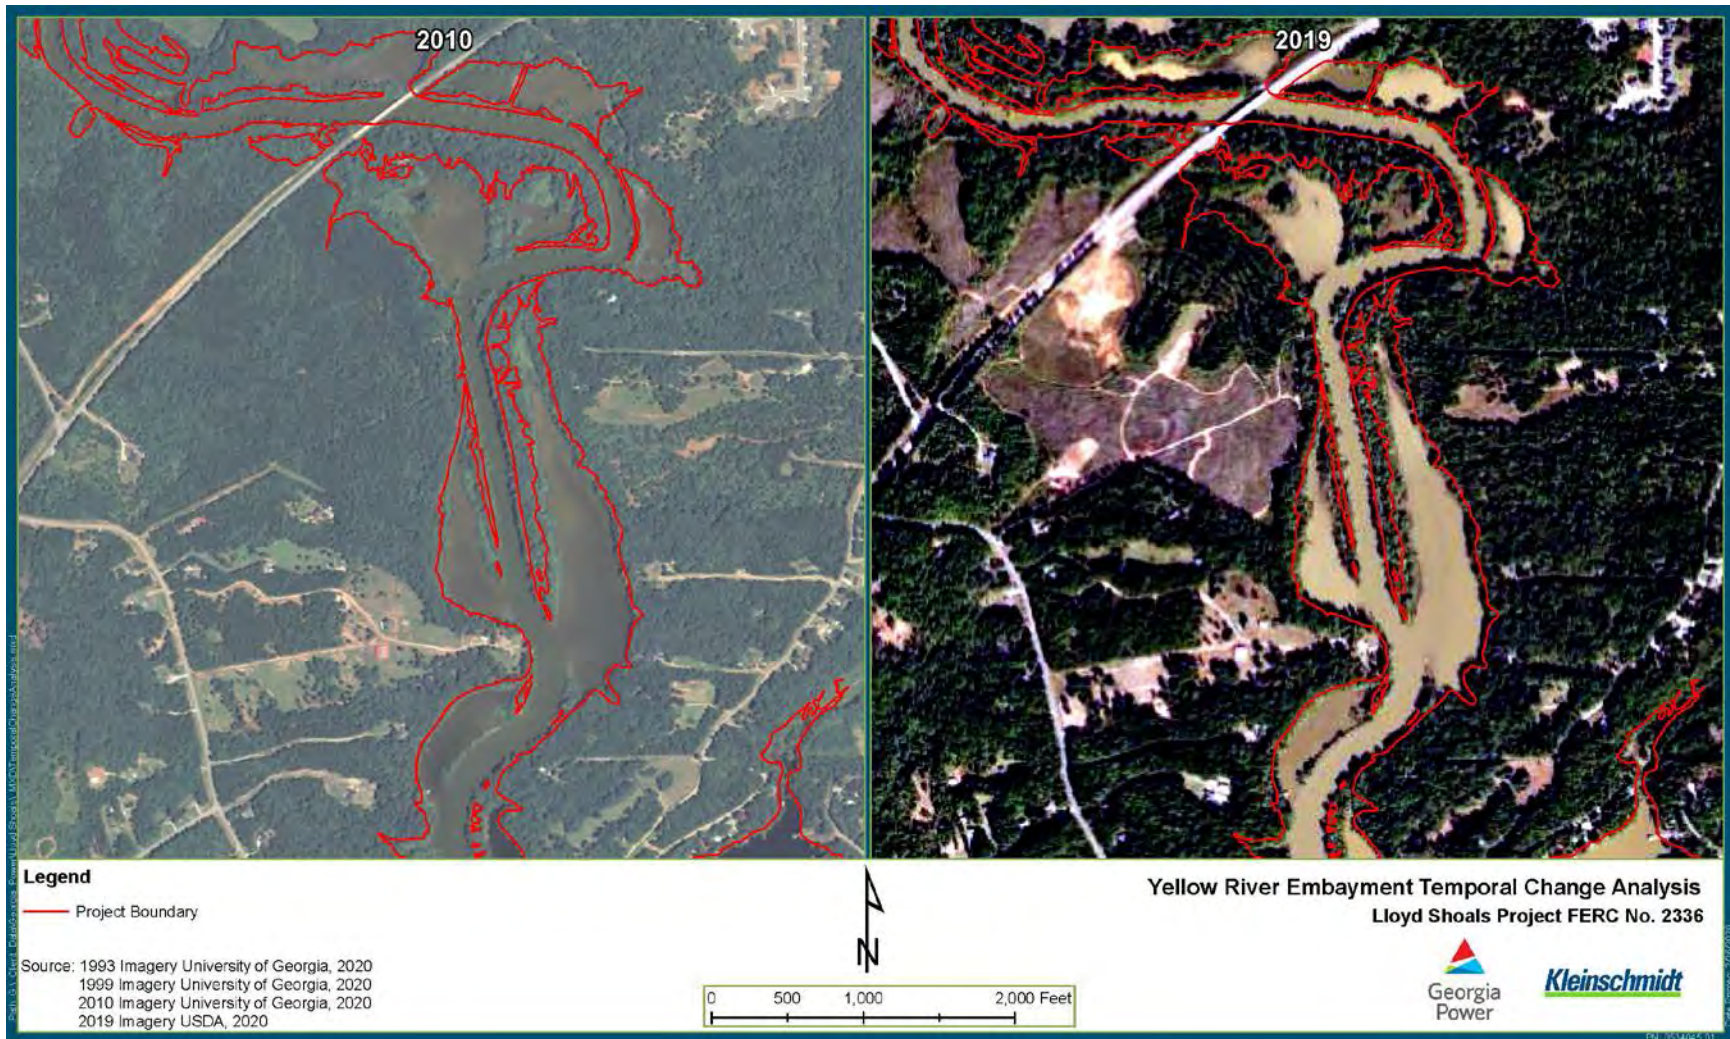
FIGURE 21 SHORELINE TEMPORAL CHANGE ANALYSIS YELLOW RIVER

Figure 21 and Figure 22 compare the 1993, 1999, 2010, and 2019 aerial imagery of the Yellow River embayment. This section, which extends from the Hwy 36 bridge crossing downstream toward the South River confluence, is a dynamic reach showing some signs of sediment deposition and scour as part of natural sediment transport processes. Similar to the South River embayment, sediment deposition appears to be focused along points, islands, and the mouths to backwater areas. The most apparent change in the area within the project boundary is some loss of standing trees in certain undeveloped backwater areas over time. Outside of the project boundary, residential construction was most prevalent between 1993 and 1999. A large tract of upland forest along the western bank appears to have been recently logged in the 2019 imagery. Three shoreline survey sites were located in this reach. Two were classified as natural and one as landscaped-natural. All of the sites had stable banks and none had any shoreline structural stabilization practices.

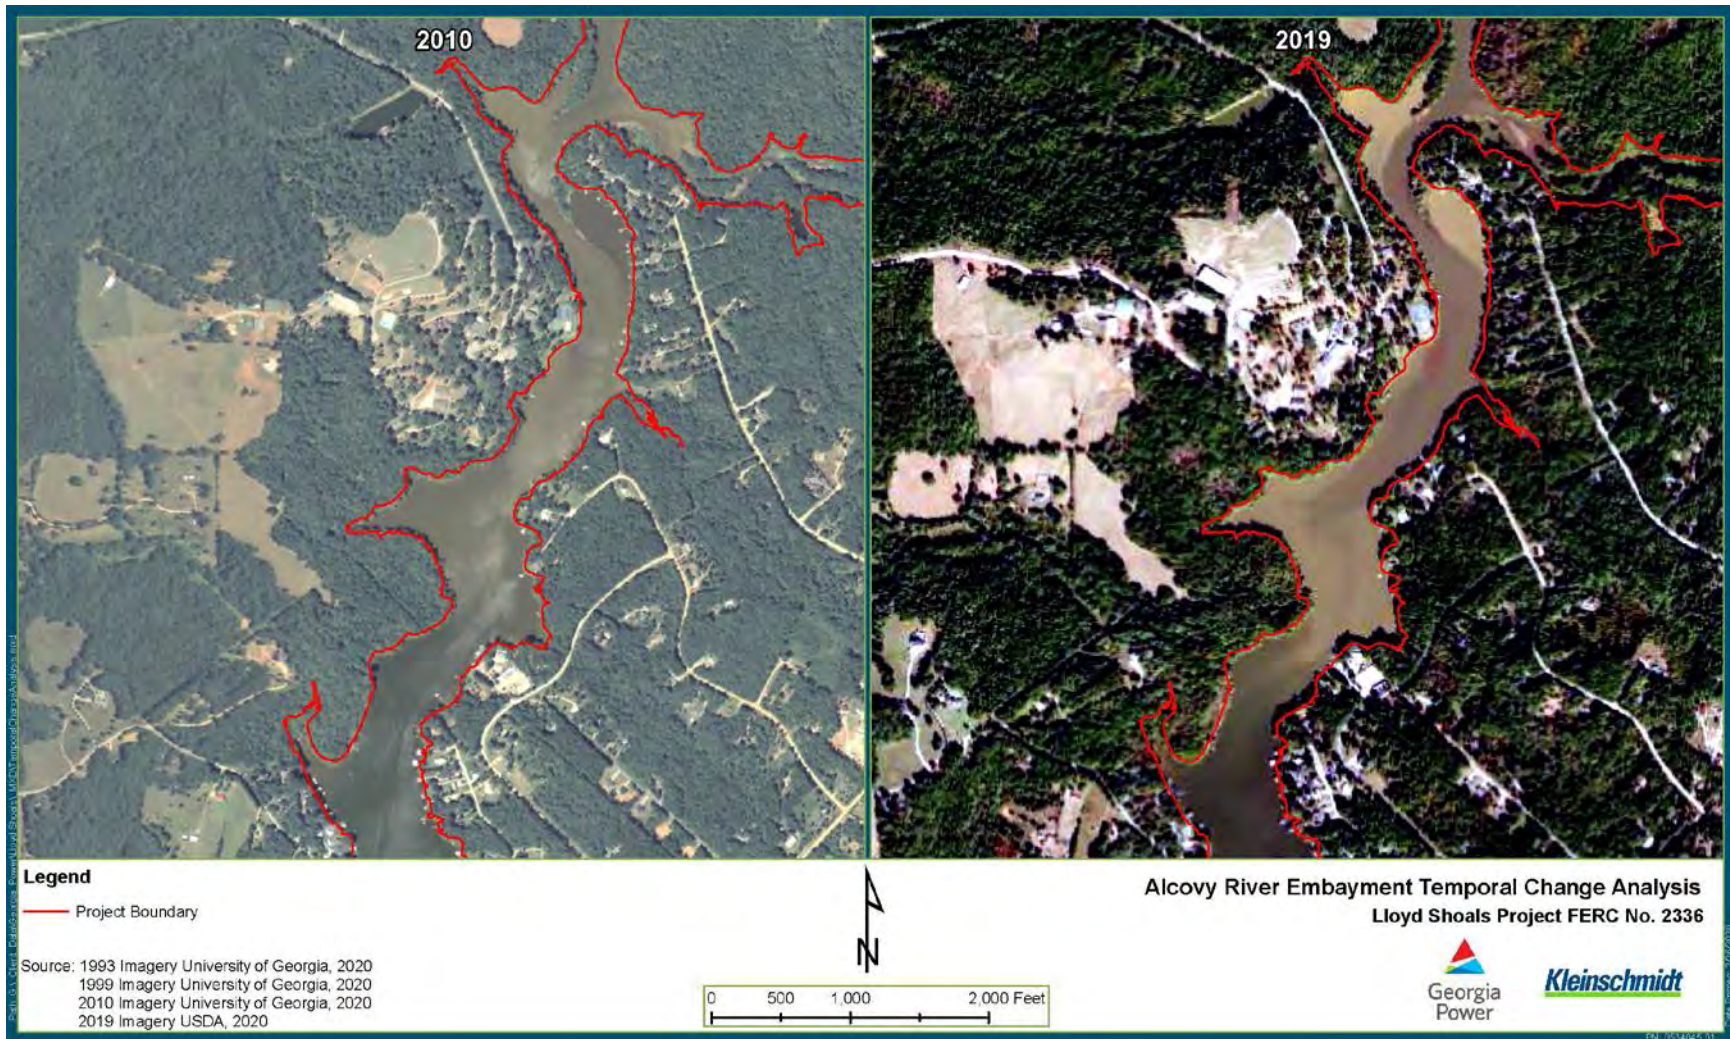
FIGURE 24 SHORELINE TEMPORAL CHANGE ANALYSIS ALCOVY RIVER

Figure 23 and Figure 24 compare the 1993, 1999, 2010, and 2019 aerial imagery of the Alcovy River embayment. This section is in the upstream reach of the embayment. Similar to the South and Yellow River embayments, this section shows signs of sediment deposition as conditions change from a riverine to a lacustrine system. Sediment deposition is primarily focused in the upper portions of the reach near bends in the river channel. Deposition has resulted in the creation of sandbars and islands that appear to grow and shrink as natural sediment transport processes occur over time. The area has experienced increased residential construction over the time period, although not of the same magnitude as the Tussahaw Creek embayment. Homes along the shoreline were primarily built along the eastern shoreline. Uplands areas of the eastern side have remained primarily undisturbed aside from residential construction. The western side has agricultural fields in the upland boundaries. Only one survey section occurred in this area, AR-27. It was classified as natural with stable banks and had no shoreline stabilization practices.

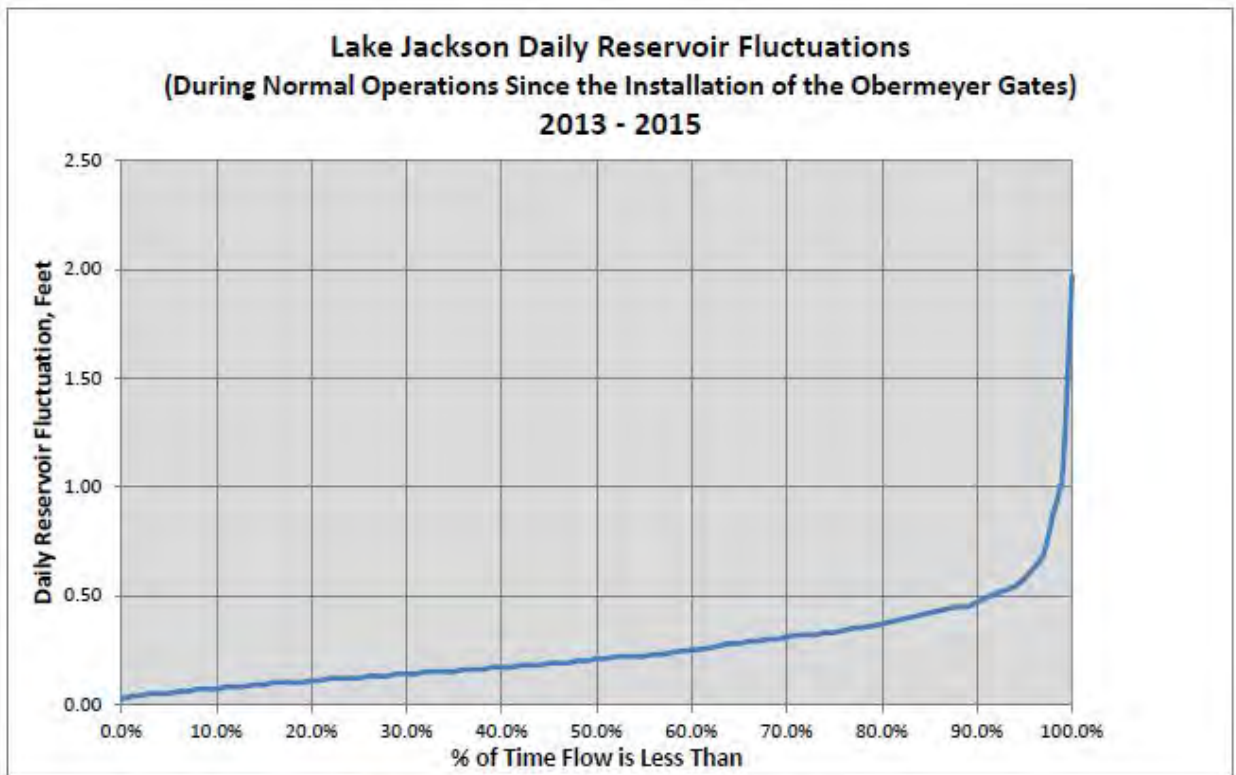
FIGURE 25 LAKE JACKSON DAILY RESERVOIR FLUCTUATION

For the years 1997 through 2016, daily reservoir fluctuations for Lake Jackson were less than 1.5 ft 98 percent of the time and less than 1.0 ft 95 percent of the time. Since the installation of the Obermeyer gate system in 2012, daily reservoir fluctuations were reduced for 2013-2015 (Figure 25).
