# CCR SURFACE IMPOUNDMENT EMERGENCY ACTION PLAN

Georgia Power Company  
Plant Hammond  
Ash Pond AP-1  
State ID: 057-037-04326  
NID: GA04307  
Floyd County, GA

**ISSUE DATE:** April 15, 2022  
**REVISION #:** 3

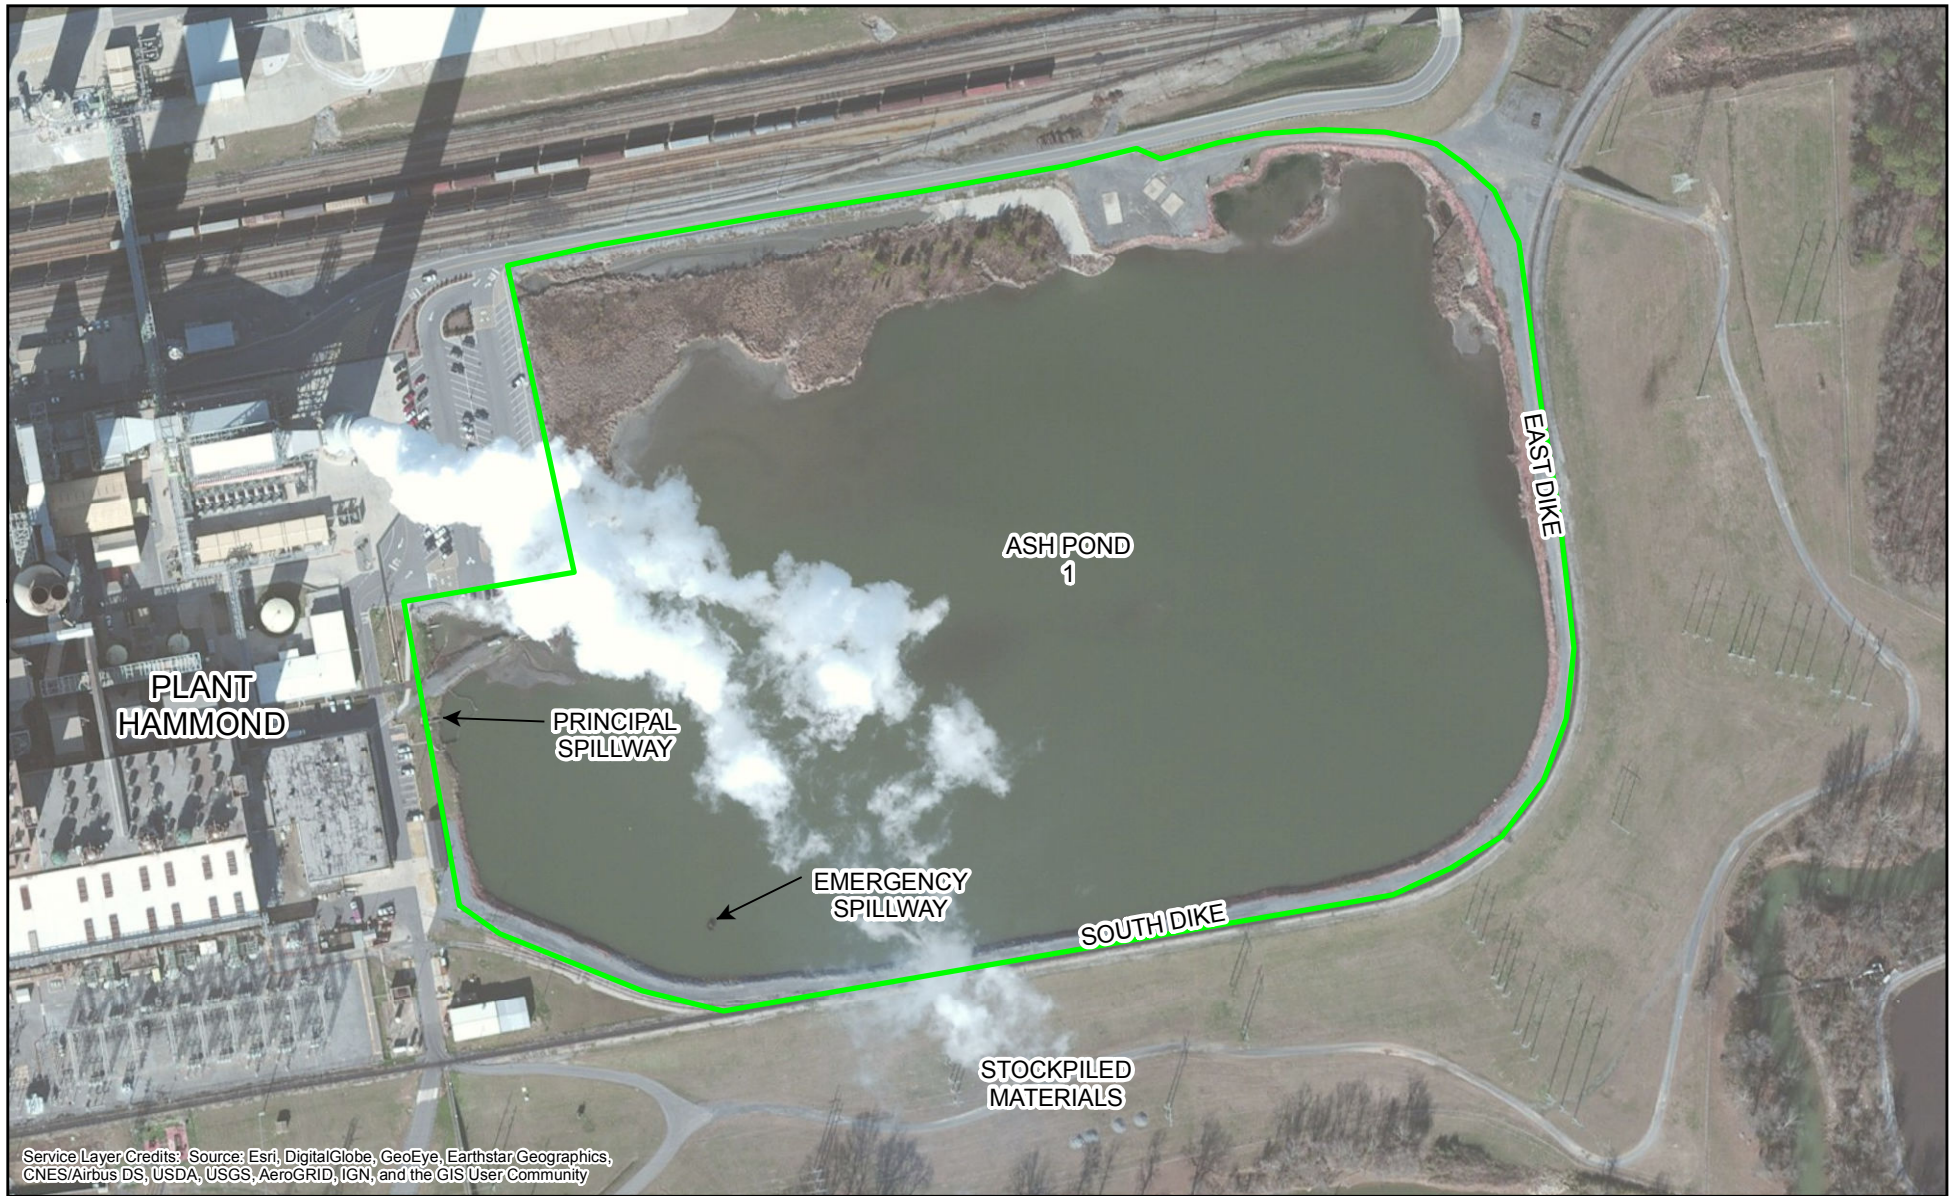
**FIGURE 2**  
**ASH POND 1 OVERVIEW**  
**PLANT HAMMOND**  
**FLOYD COUNTY, GEORGIA**

AP-1 is approximately 35 acres in size at its normal pool elevation of 584 feet (Appendix A – Figure 2). AP-1 has earthen embankments (also referred to as dam/dike) on its east and south sides and is incised into the existing ground on its north and west sides. The dam/dikes have a maximum height of approximately 15 feet. The upstream face of the dam/dike is covered with a riprap erosion protection blanket, which extends approximately 10 feet down the slope. The crest surface is composed of grass and a gravel access drive. Downstream slopes are covered with grass. Outlets are located at the southern and southwestern portion of AP-1 and consist of:

GPC and emergency personnel are able to access the AP-1 dam/dike from the main portion of Plant Hammond by paved or gravel-surfaced roadways. Figures 1 and 2 show the location of AP-1 on Plant property.
